Rail Accident Report

Collision between road-rail vehicles near Ramsden Bellhouse, Essex 2 May 2021

Report 09/2022
September 2022

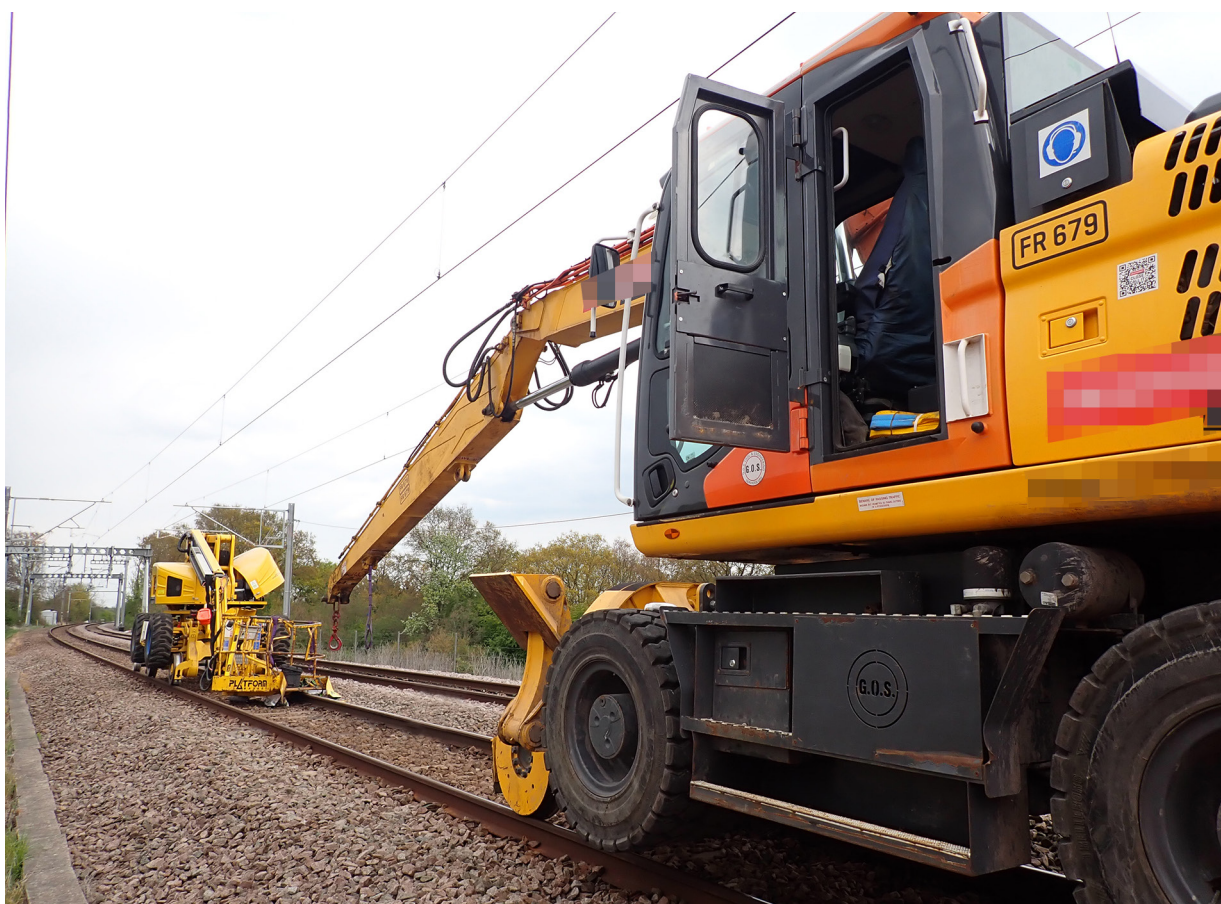
A possible underlying factor was the lack of clarity in the role of machine controllers during travelling movements. This may have contributed to a lack of warning of the impending collision from the crane controller, who was riding in the cab with the crane operator.

Figure 2: The rail mounted crane and elevated platform involved in the collision after being moved apart

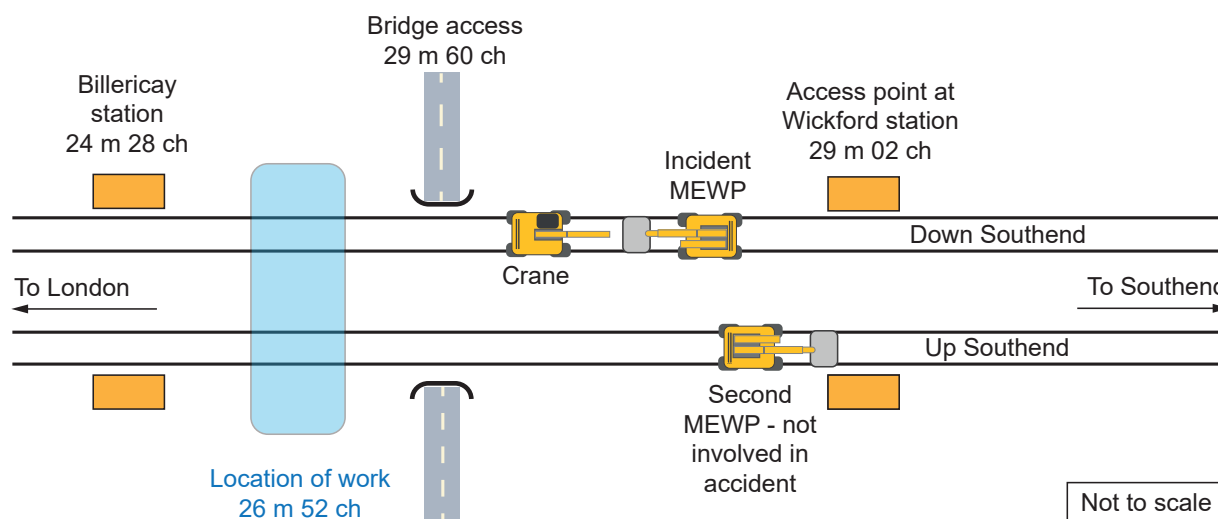
Figure 3: Location of work and relative positions of machines immediately before the collision

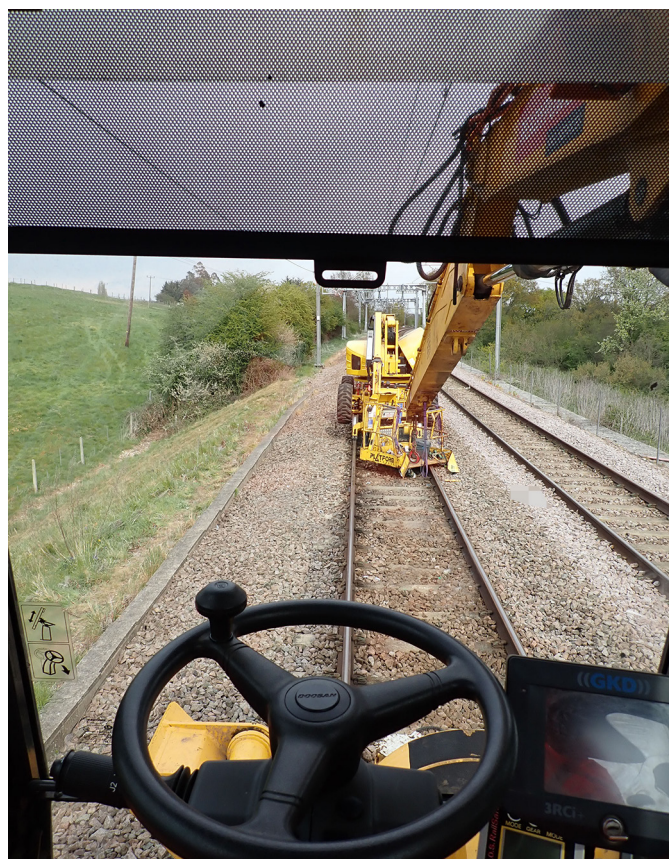
- 30 The crane operator stated that during the journey, he had seen the distance between the machines getting smaller, so he had reduced the speed of the crane. He also stated that the rising sun had become a problem, so he had reached out to pull down a roller blind type sunshade, which is positioned above the windscreen. When examined by RAIB after the accident, the sunshade had been lowered to a point where the MEWP would still be visible to the operator (figure 7).

- 32 The crane operator stated that after lowering the sunshade, he suffered a temporary blindness from 'sunspots' caused by looking into the sun. To relieve this, the operator turned his head to look out of the side window and continued to do this until he heard a shout when the crane arm collided with the MEWP basket. According to the MEWP data recorder, this occurred at 06:59 hrs.

Figure 7: The view from the crane operator's seat with the sunshade drawn at the accident location (in daylight)

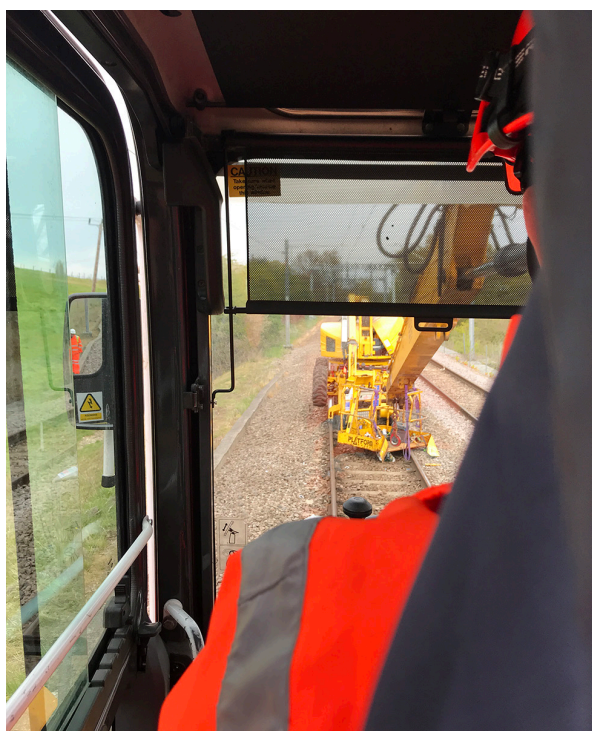
- 49 For the journey from the site of work, the crane controller sat in the cabin of the crane, on a seat facing 90 degrees to the left of the direction of travel and located behind the operator. The view out of the front windscreen from this seat would have been restricted by the operator sitting in the seat in front, but not so much that the view of the MEWP on the track was fully obscured (figure 8).

Figure 8: The view from the rear seat of the crane with a substitute operator (in daylight)
