Rail Accident Investigation Branch

Rail Accident Report

Freight train derailment at Petteril Bridge Junction, Carlisle 19 October 2022

Report 10/2023
October 2023

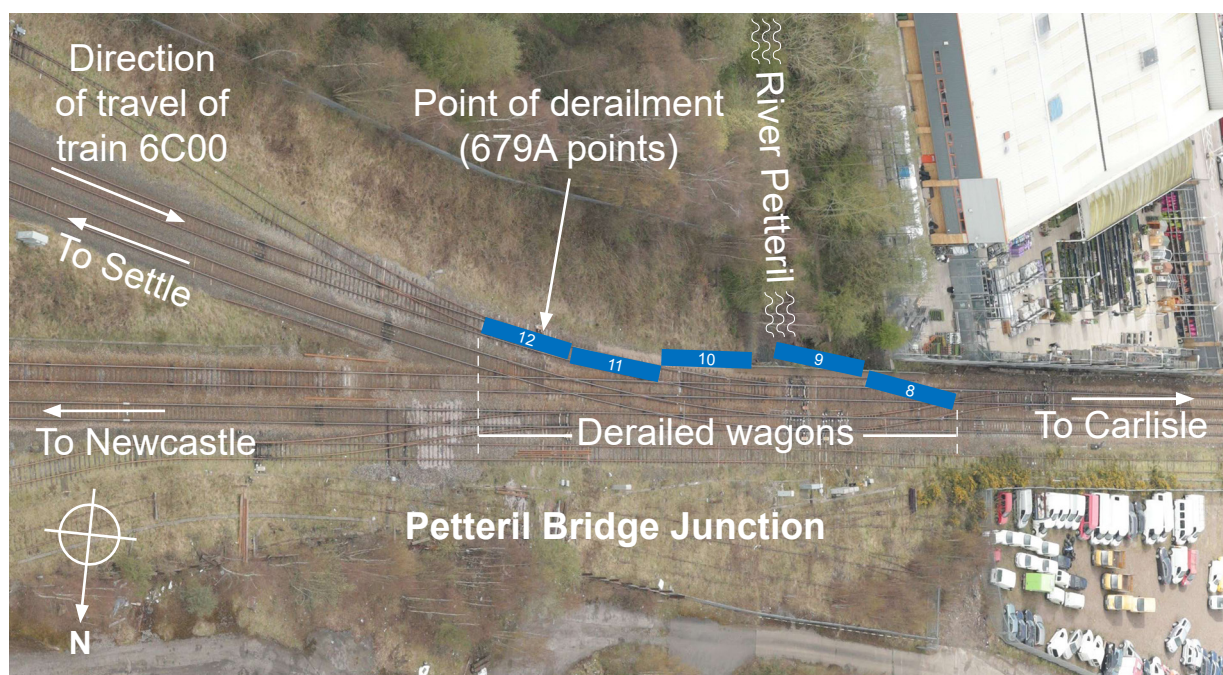
Figure 4: Aerial view of the derailment site, showing positions of derailed wagons (background image courtesy of Network Rail).

- 61 By 19:53 hrs, train 6C00 had slowed to 20 mph (32 km/h) as it approached Petteril Bridge Junction. As the train passed over 679A points in the trailing direction (figure 4), the leading wheelset of the ninth wagon derailed to the left and started to severely damage the track as both of its wheels ran along the sleepers instead of the railhead. This damage led to subsequent wheels of the following wagons becoming derailed to the left.

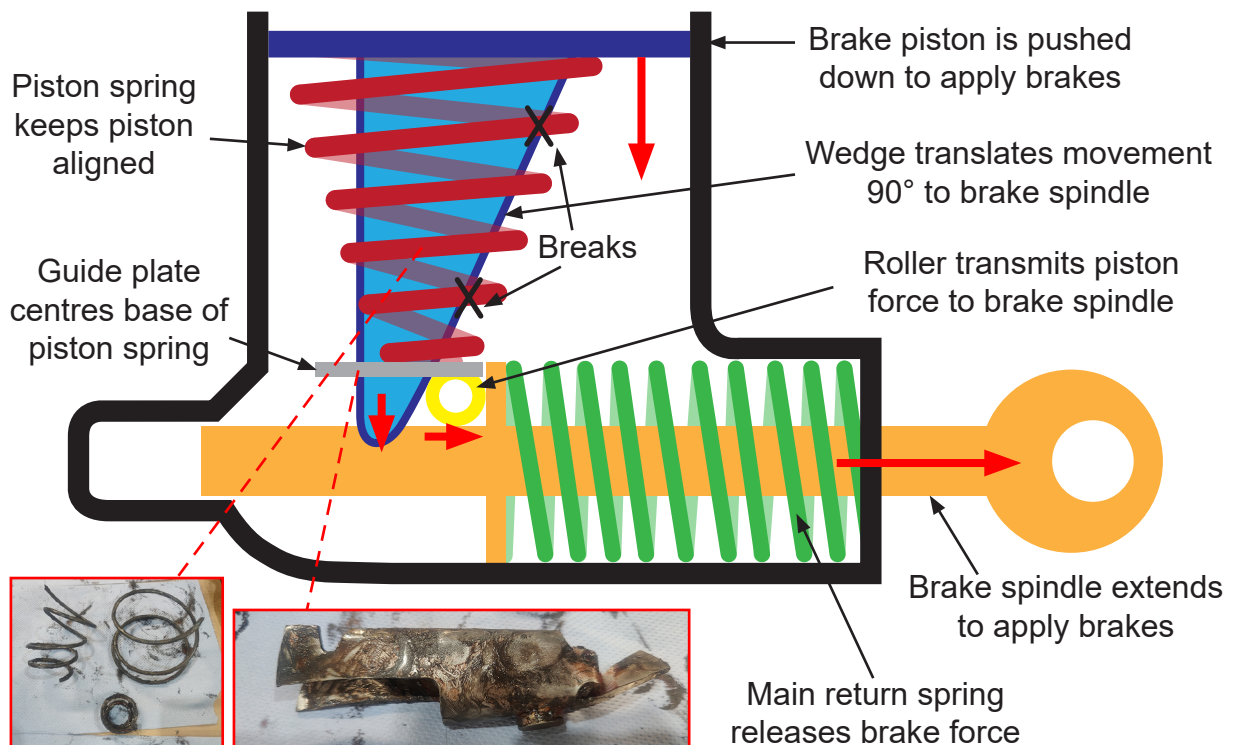
Figure 12: Internal arrangement of the brake cylinders.

- 45 The piston spring had broken in two locations and RAIB commissioned a metallurgical examination of it to determine the nature of the breaks. This found that the first break showed signs of fatigue cracking that would have developed over many cycles of operation in normal service. The second of the breaks was due to the dislodged spring being trapped in the brake cylinder mechanism and being crushed. The conclusion of the examination was that fatigue had initially led to the spring failing and becoming dislodged, resulting in the spring and its guide plate becoming loose in the mechanism and subsequently becoming crushed during service operations. The metallurgical report concluded that it was likely that the cracking, and both the resulting breaks, had occurred during normal service, before the derailment.

- 46 If the dislodged spring and guide plate had become wedged in the brake cylinder mechanism, it is possible that it could have resulted in the brake force on that bogie not being fully released after a brake application. The maximum force that could have been applied would have been a normal full service brake application. However, this would have resulted in the brakes being applied to both wheelsets in the bogie, and not just to the wheelset that slid, which would also cause additional brake wear on the brake blocks for both wheelsets. Examination of the wagon after the derailment did not show any significant difference in the brake block wear between the two bogies on the ninth wagon, nor any evidence of excess heat having been generated, suggesting that any possible abnormal brake force from this brake cylinder had a minimal effect.

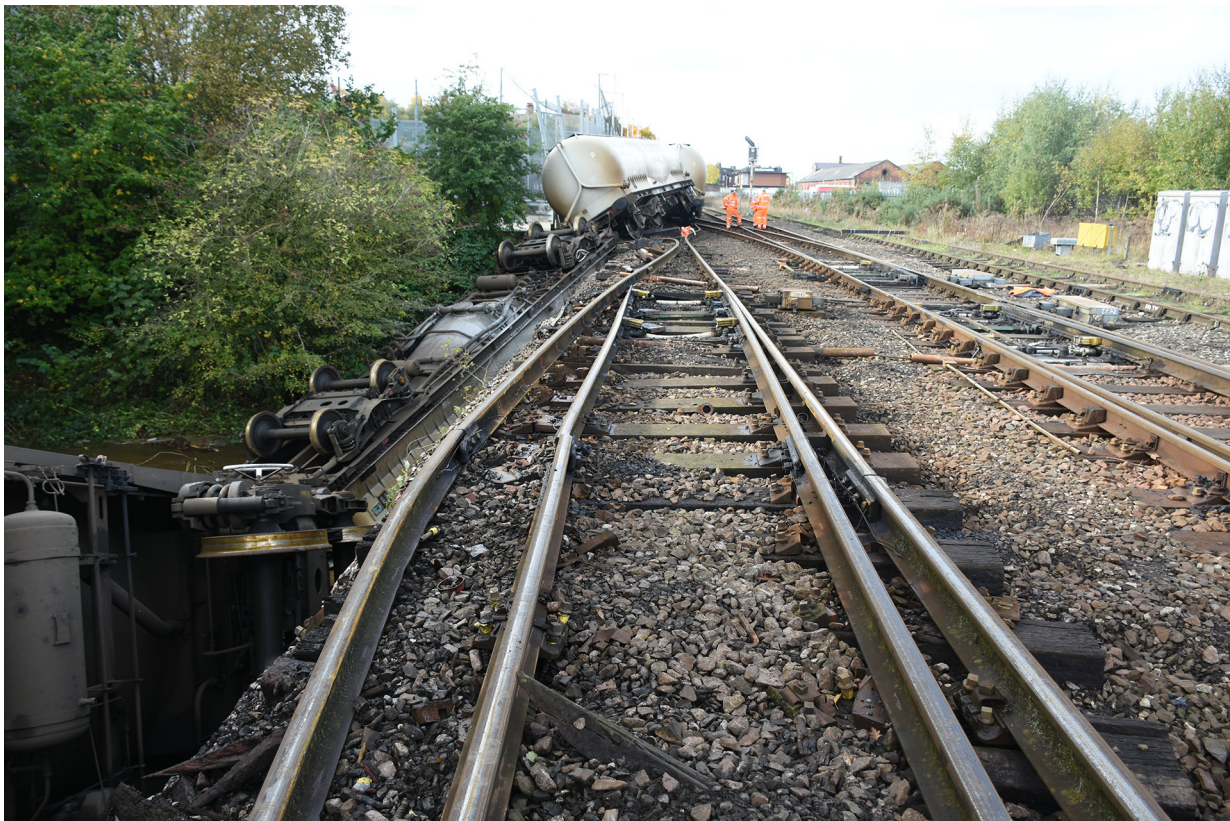
- 62 The derailed wagons destroyed the set of points at Petteril Bridge Junction, which was located on top of the bridge over the river. The derailed wagons, which were running to the left of the track, ran against the side of the bridge parapet wall, resulting in the wall and part of the railway formation falling into the river. This led to the ninth and tenth wagons falling off the left side of the bridge, coming to a rest with the ninth wagon upside down in the river and the tenth wagon on its side on the riverbank (figure 20). The rear of the eighth wagon also derailed to the left as it was dragged sideways by the front of the ninth wagon.

Figure 20: Damage to the track and bridge at Petteril Bridge Junction.

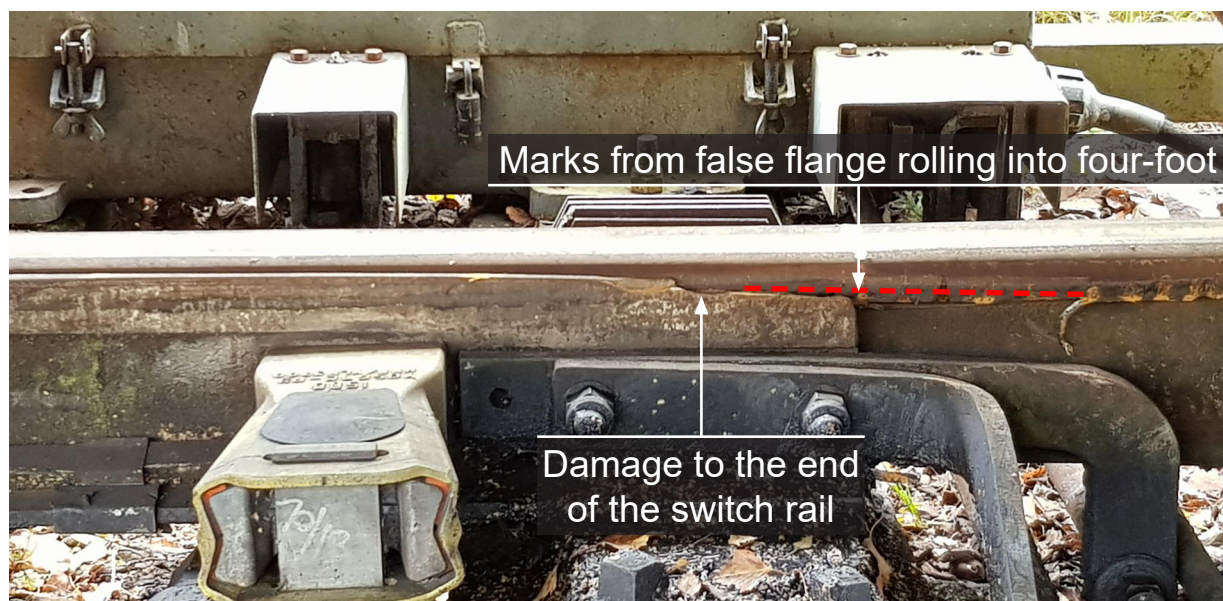
69 Marks at the site showed that, during the initial stage of the derailment, the outer edge of the false flange on the leading left wheel of the ninth wagon had become trapped between the converging stock rail and switch rail at 679A points (figure 23). In the absence of a false flange, the outer edge of the wheel would have passed over the top of the converging rails, with the contact surface of the wheel transitioning from the switch rail to the stock rail. Figure 24 shows the marks on the inside of the stock rail as the outer edge of the trapped false flange on the leading left wheel ran along the inside of it at the tip of the switch rail as the wheel dropped into the four-foot (the gap between the running rails).

Figure 24: Switch rail at 679A points.
