# Rail Accident Report

## Passenger train collision with a road vehicle at Redcar level crossing, Redcar and Cleveland 1 May 2024

Report 05/2025  
April 2025

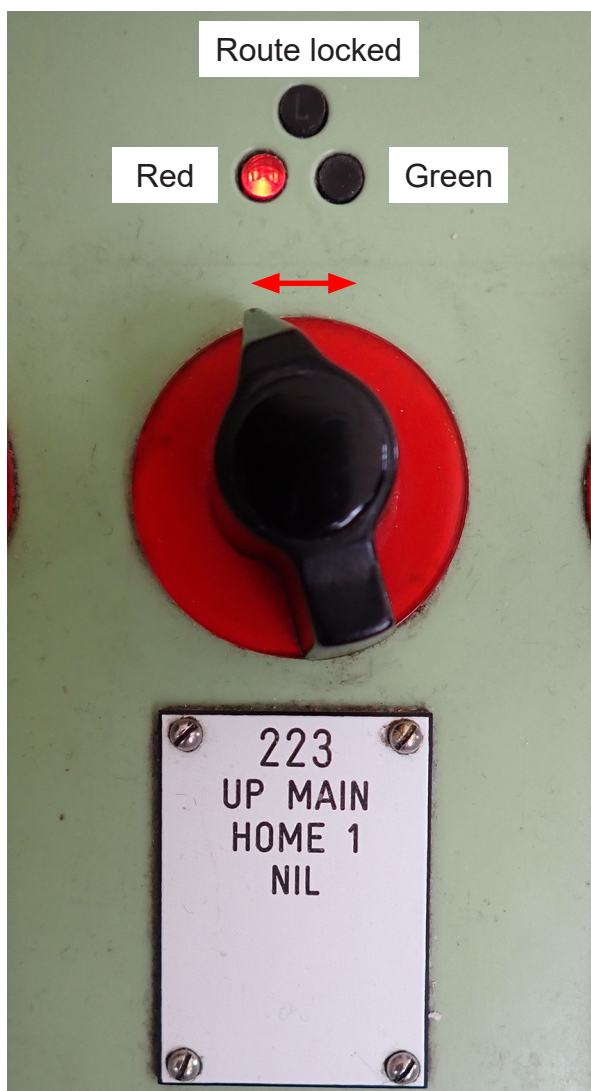
Figure 7: Signal R223 control on the Redcar signalling panel.

- 41 There are three indicator lamps associated with the signal control switch. One is lit green when the signal is showing a green aspect. A second is lit red when the signal is showing a red aspect. The third is lit white when a train is in the section between signal R223 and Redcar Central station. This shows that the route is 'locked', meaning that the signaller is unable to open either of the two level crossings after a train has passed signal R223 and until the train has passed both crossings. This is known as 'approach locking' (see paragraphs 131 to 133), although this protection system is not relevant to this accident as Redcar level crossing was already open when the accident occurred.

53 The signaller was aware that the green indicator lamp (figure 7) was lit as train 2D11 approached the signal. Their perception was that the lamps flickered and went out as that train passed it. It is very likely that the green indicator lamp actually went out as intended as the train passed the signal, and that the red indicator lamp became lit momentarily before going out as it failed. The signaller was unable to recall if the white indicator lamp lit after the train passed, but the circuitry for this lamp suggests that it would have been lit while the train was between signal R223 and Redcar Central station (paragraph 41).

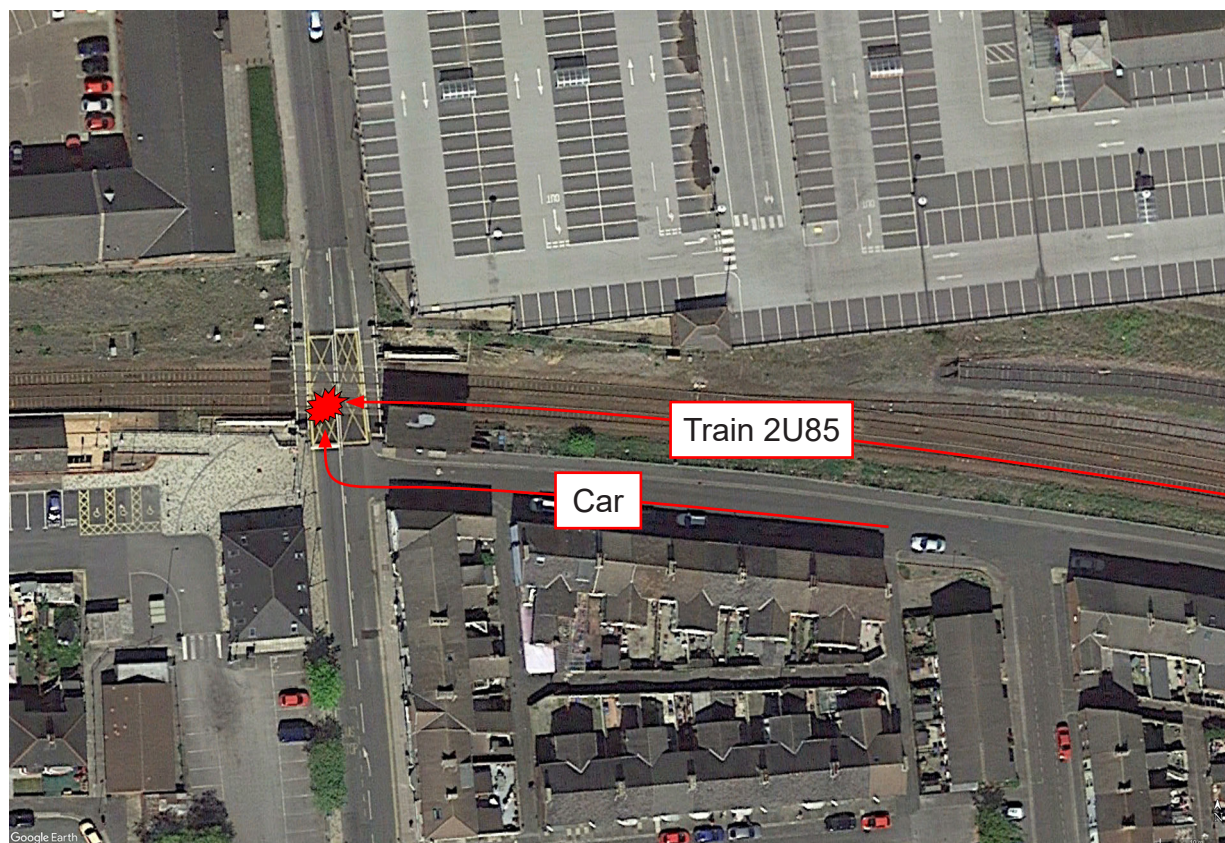
Figure 10: Direction of approach for the car and the train (courtesy of Google with RAIB annotations).

46 Before entering the crossing, the car driver, who was very familiar with it (paragraph 32), noted that there was no queueing traffic, which they found to be very unusual. The driver saw that the wig-wag lights were not flashing, and that the level crossing gate was open to the road.

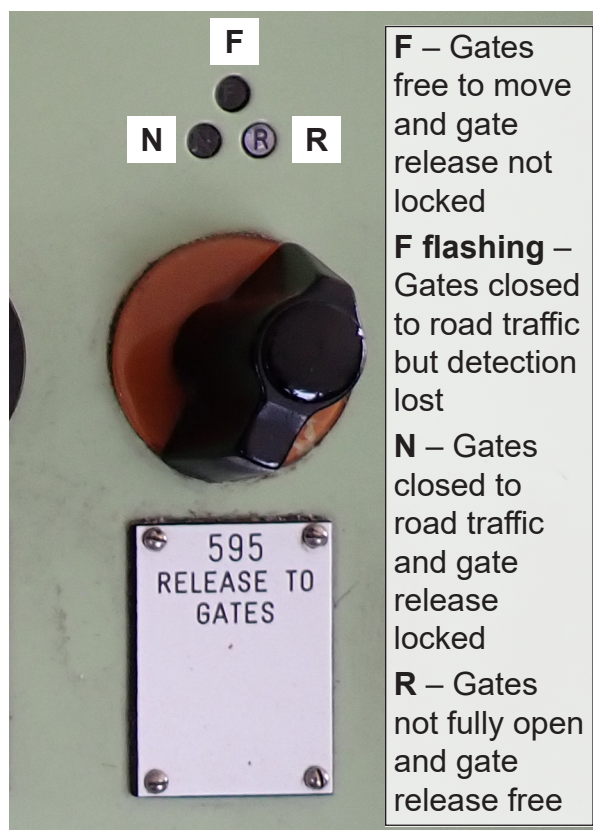
Figure 11: Crossing release indications.

- 68 There are small indicator lamps associated with the crossing release switch (paragraph 43 and figure 11). Of these, the 'N' indicator lamp (which tells the signaller that the gates are not locked after being closed to road traffic) could have alerted the signaller that the crossing was open. Witness evidence shows that the signaller did not observe the status of these lamps. This is because these indications are small and are intended to indicate the status of the interlocking rather than whether the crossing is closed. As a result, they are not routinely checked during signalling operations to determine the status of Redcar level crossing and are not included on the route cards (see paragraph 72).

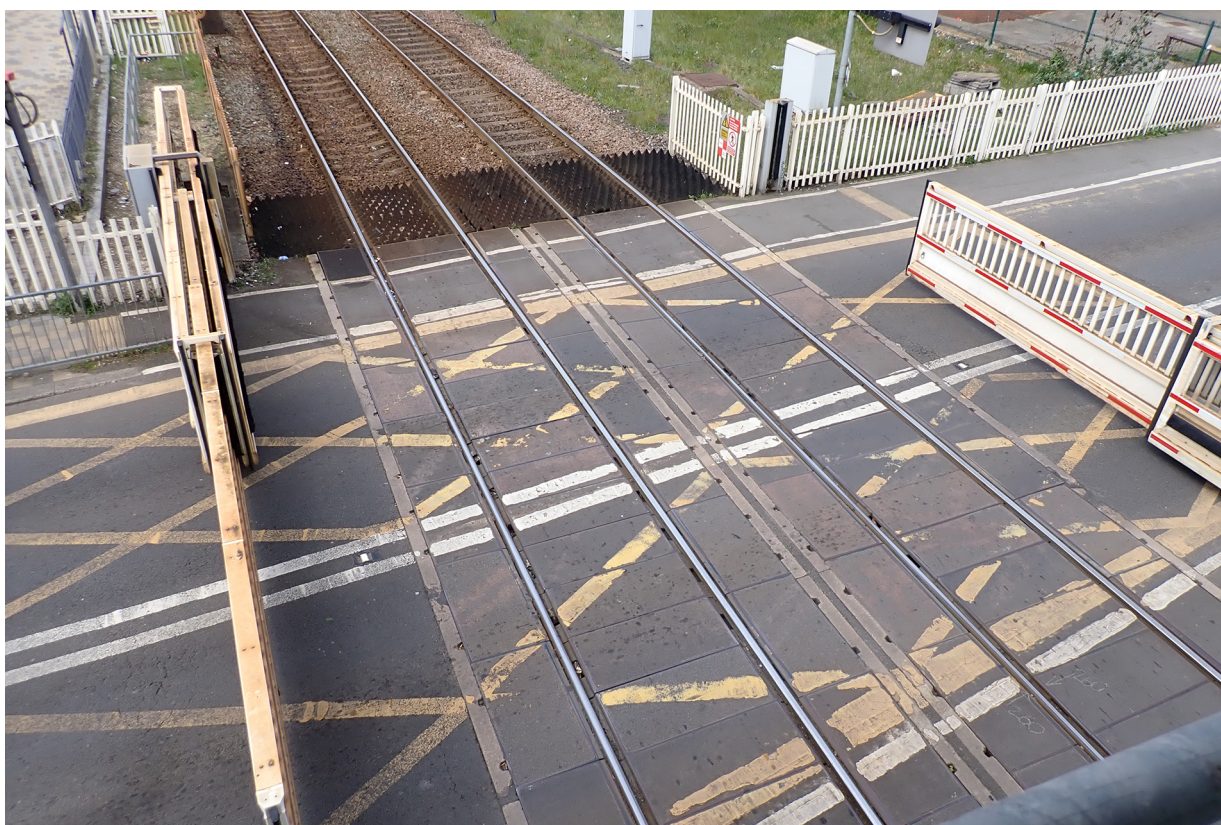
*Figure 12: View of Redcar level crossing from the operator's pedestal.*

- 94 The level crossing gates at Redcar are of a unique design on Network Rail's infrastructure. They each consist of a horizontally extending, cantilevered gate (figure 12) that is motor-driven and operated from the pedestal in Redcar signal box (figures 6 and 9). These gates were installed in 2016 and replaced a set of wooden, motor-driven, swung gates. These swung gates had suffered from a history of unreliable operation, partly down to the wind that tends to blow in from the sea at Redcar. Network Rail was unable to replace them with conventional lifting boom barriers because the position of the signal box did not allow sufficient space for the necessary equipment. Unlike Church Lane level crossing barriers, those at Redcar do not rise into the air and so are not visible from a distance when they are open to road traffic (figure 13).

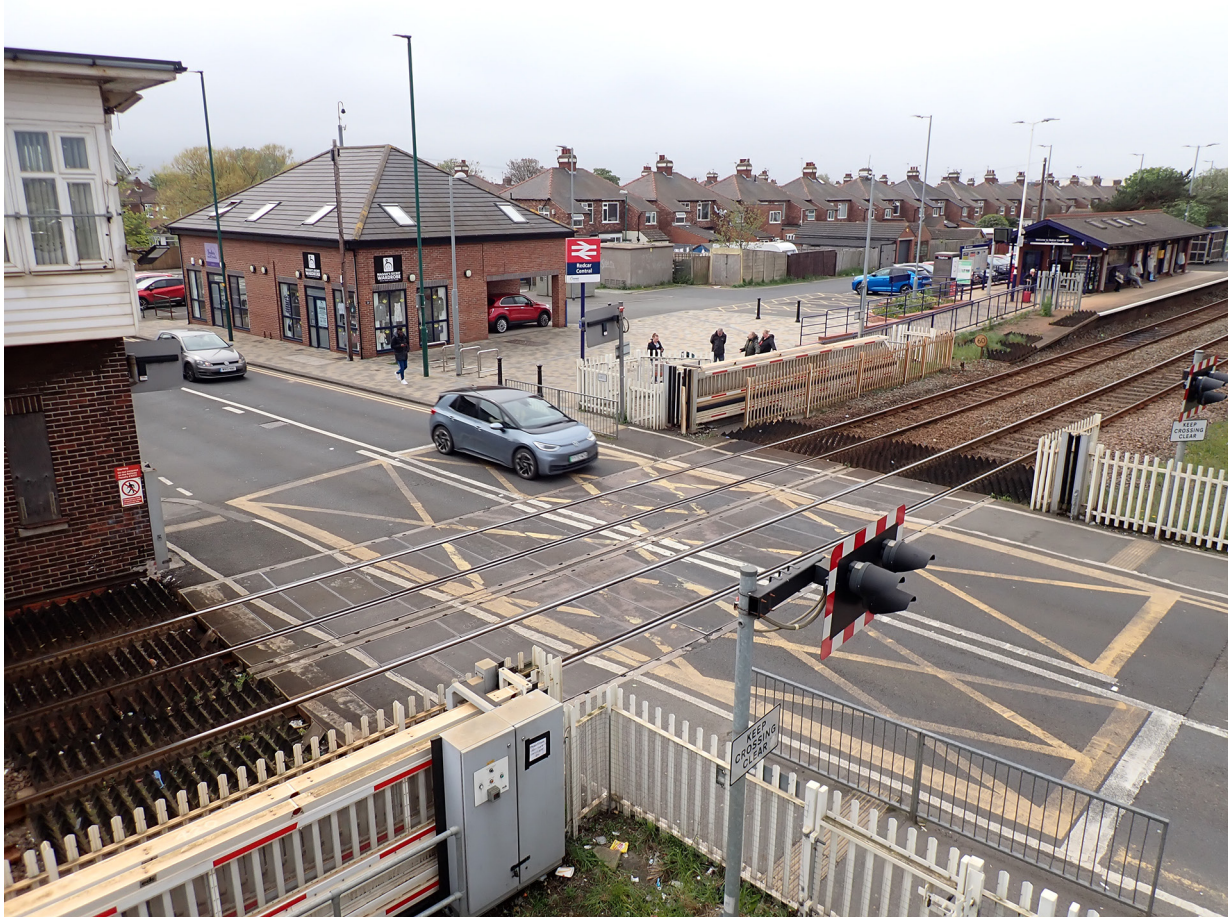
Figure 13: View of Redcar level crossing with the gates open to road traffic.

- 95 On the day of the accident, after the signaller had reopened the barriers to allow traffic to ease, there was no road traffic passing across the crossing while train 2U85 approached. This meant that the train driver was provided with no visual clue from crossing road traffic that the gates, and therefore the road, were still open, which would have prompted the driver to brake. This was also the reason that the car driver was able to immediately exit the side road and enter the crossing (paragraph 32).

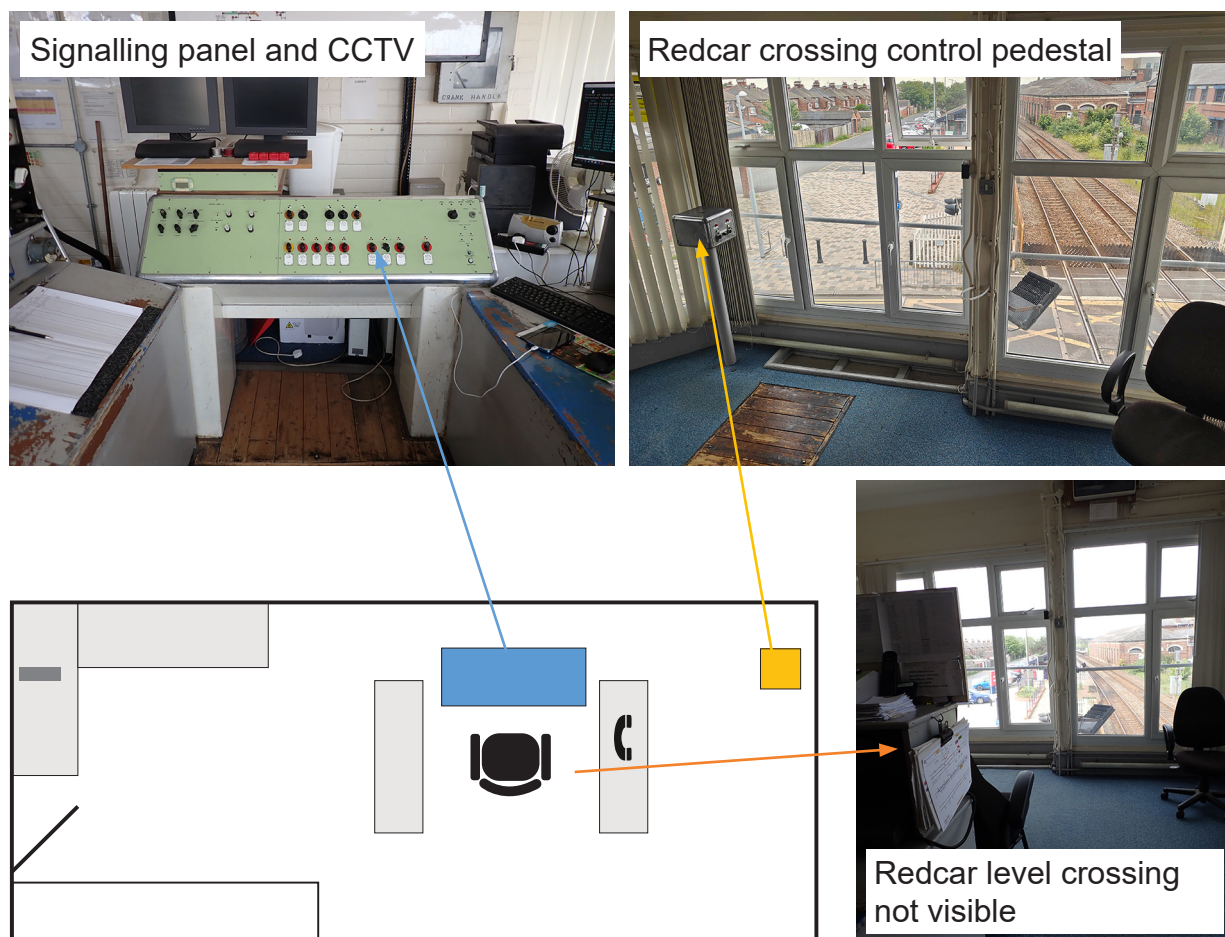
Figure 14: Layout of the signal box.

- 122 The Redcar signaller was therefore in a situation where information about the level crossings that they were operating came from two different locations in the signal box. The signaller has to walk between these locations routinely to complete the sequence necessary for the passage of each train. The design of the crossing gates also means that their position cannot be seen from the seat at the signalling panel. Although there are small indications associated with the level crossing release switch, these are not routinely checked when signalling trains (paragraph 68). In the case of this accident, the lack of visibility of both crossings when setting the route meant that the signaller did not have an effective reminder that the Redcar level crossing was still open, after they were interrupted while setting the route for train 2U85.

- 124 No ergonomic assessment of the signal box at Redcar was found in Network Rail's records. This is because there had been no operational or design changes made to the signal box, or to the level crossing, that were significant enough to require such an assessment since the introduction of the ergonomic standard. For example, the upgrade of the Redcar level crossing gates in 2016 was assessed to have had no ergonomic effect on the operation of the signal box. This was because the level crossing controls remained the same and the signal supervision of the gates remained unchanged.
