Rail Accident Report

Derailment of a passenger train at Roudham Heath, Norfolk, 6 February 2024

> Report 03/2025 February 2025

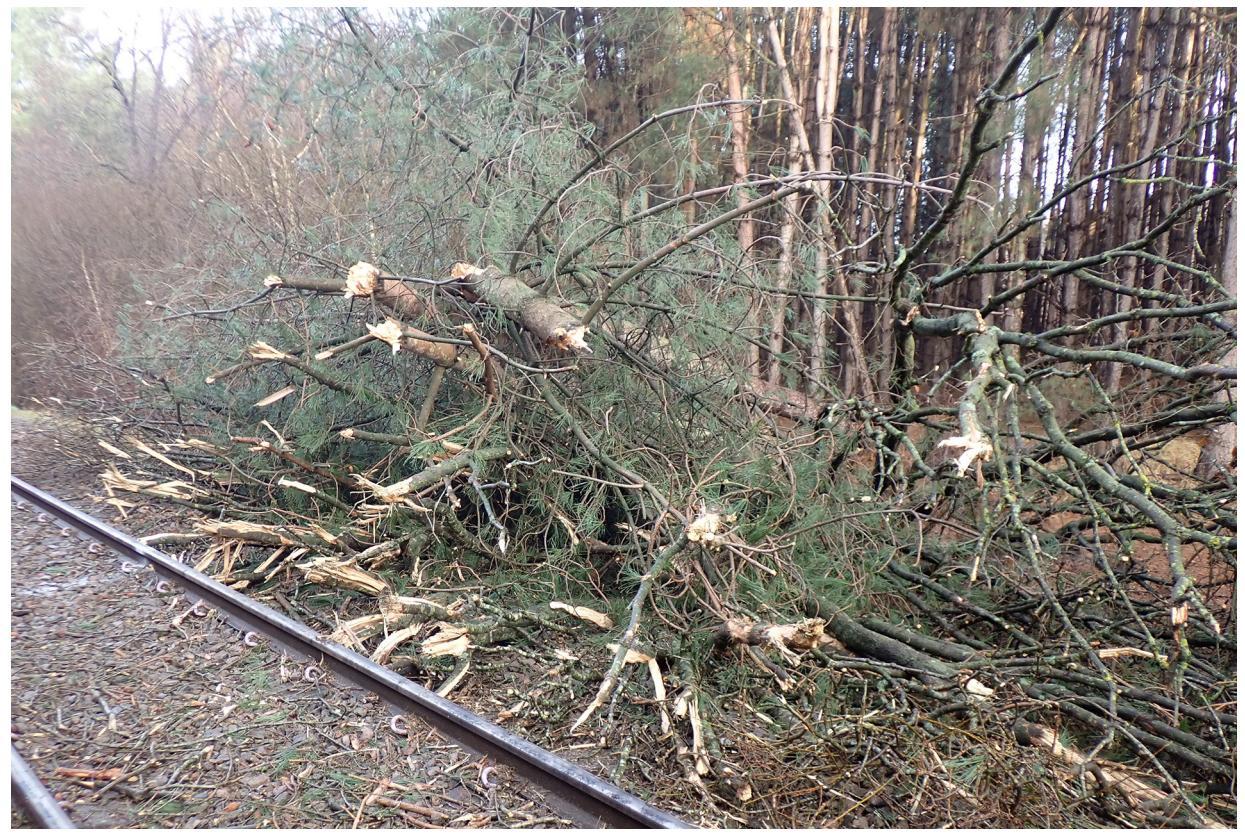
- At an unknown time between train 1R88 passing through Roudham Heath at 20:30 and the accident at 20:53, the pine tree fell towards the railway, striking and felling the oak tree, resulting in the trees fouling both the Up and Down Main lines around 180 metres east of Shadwell level crossing. Nobody witnessed the trees falling. The pine tree came to rest on top of the oak tree. At the point the trees crossed the Down Main line, the upper branches of the oak tree were just above the rail and the upper trunks and branches of the pine tree were around 2 metres above rail level (figure 3).

Figure 3: The two trees after being struck by the train.

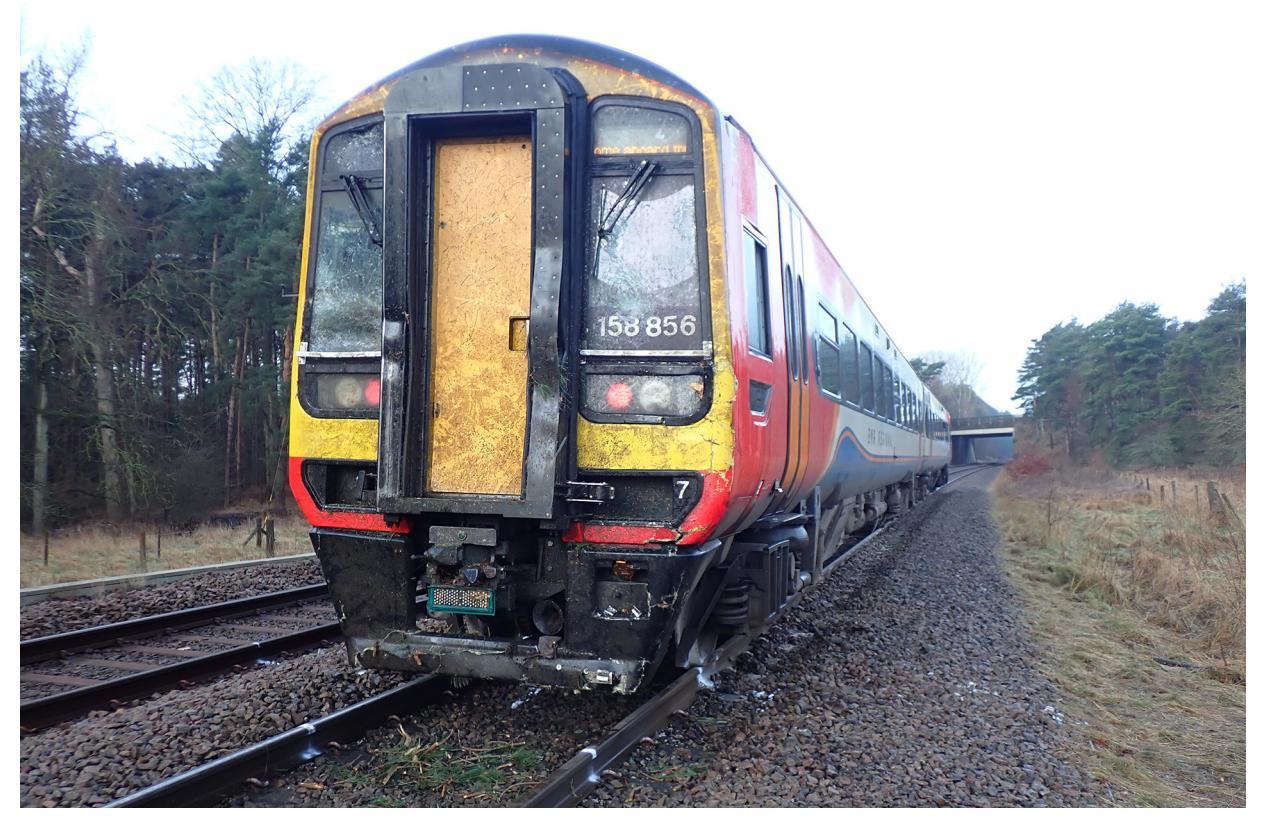
- 27 The twin stems of the pine tree were around 2 metres above rail level. As the train collided with them, the lower of the stems impacted the train at the level of its headlight assembly. The upper stem impacted halfway up the driver's windscreen, causing it to crack, although it remained in place. Both stems struck the front of the train's gangway faceplate, deforming its left-hand section (figure 4).

Figure 4: The damage to the front of the train (train shown after being rerailed).

- 83 Minor damage was evident to various places on the front and underside of the train, in keeping with the train running derailed. The gangway faceplate was deformed in two places, where it had been struck by the two primary stems of the pine tree (paragraph 27 and figure 4). The impact with these stems had also cracked both windscreens, but they remained in place with no penetration into the driving cab. There was also a small crack to an internal cab desk panel.

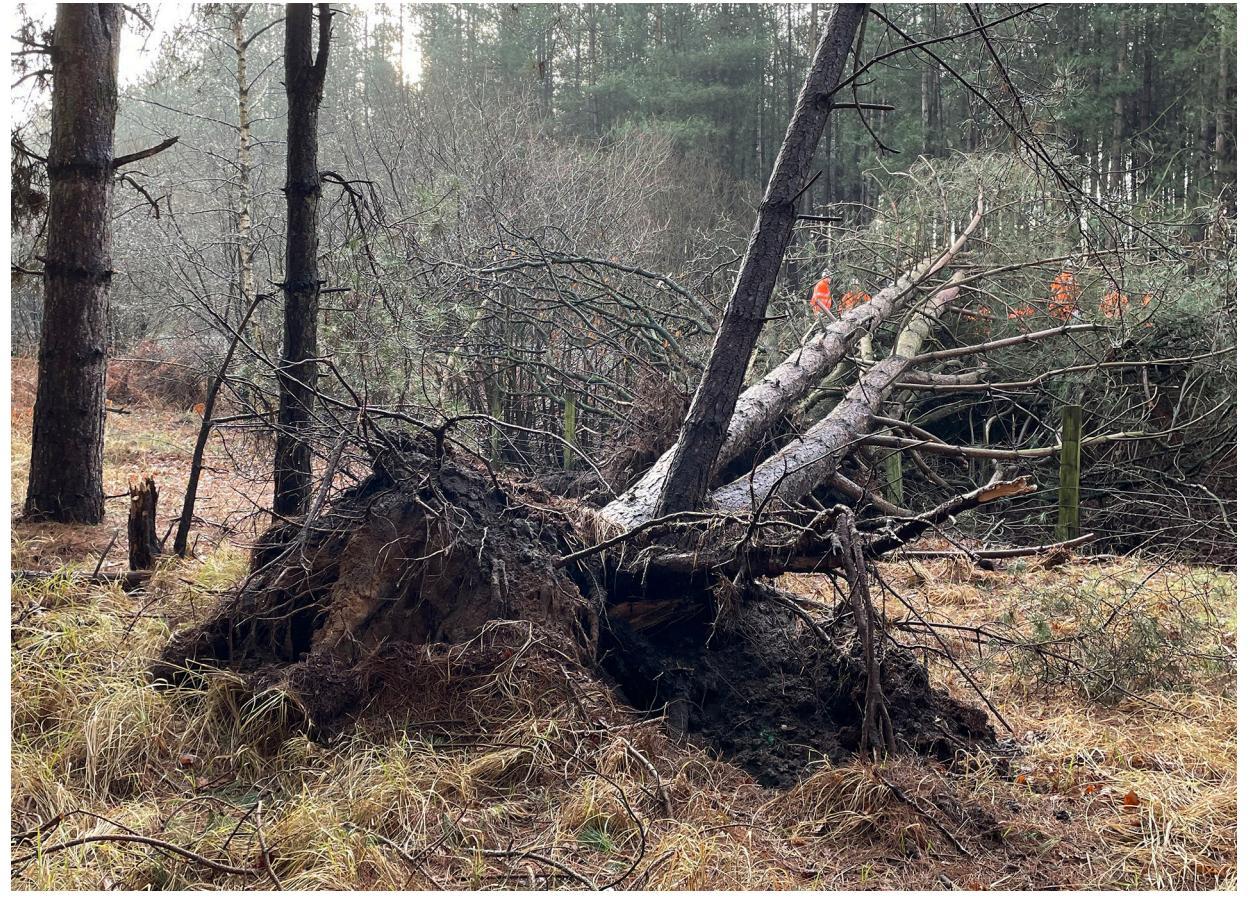
- 50 Examination of the pine tree by the arboriculturist in April 2024 showed many pulled out transport roots (figure 5), indicating this tree failed by the third mode, due to a loss of root anchorage.

Figure 5: The root structure of the pine tree after the accident, showing the many pulled out transport roots.

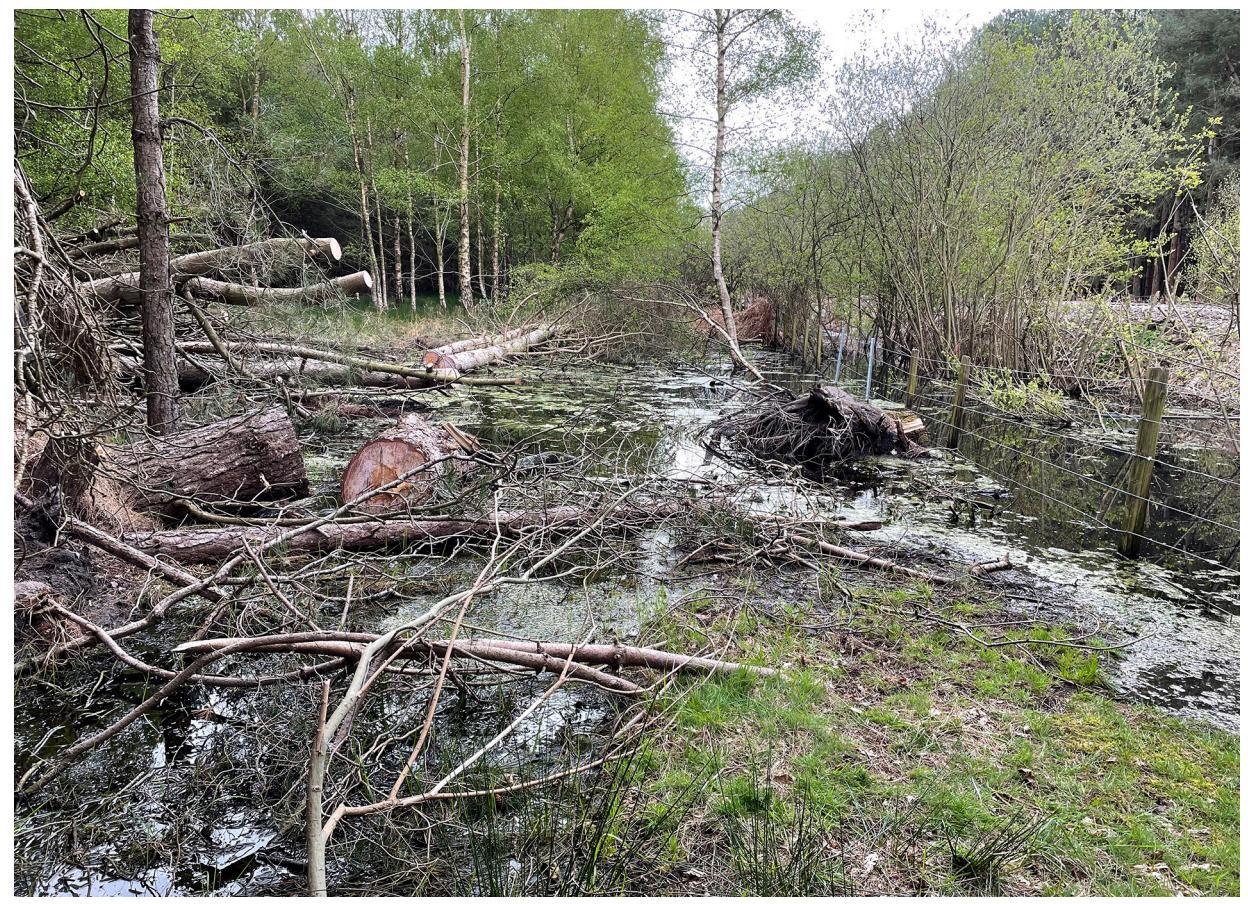
Staff involved

Figure 6: Site conditions during the post-accident inspection in April 2024.

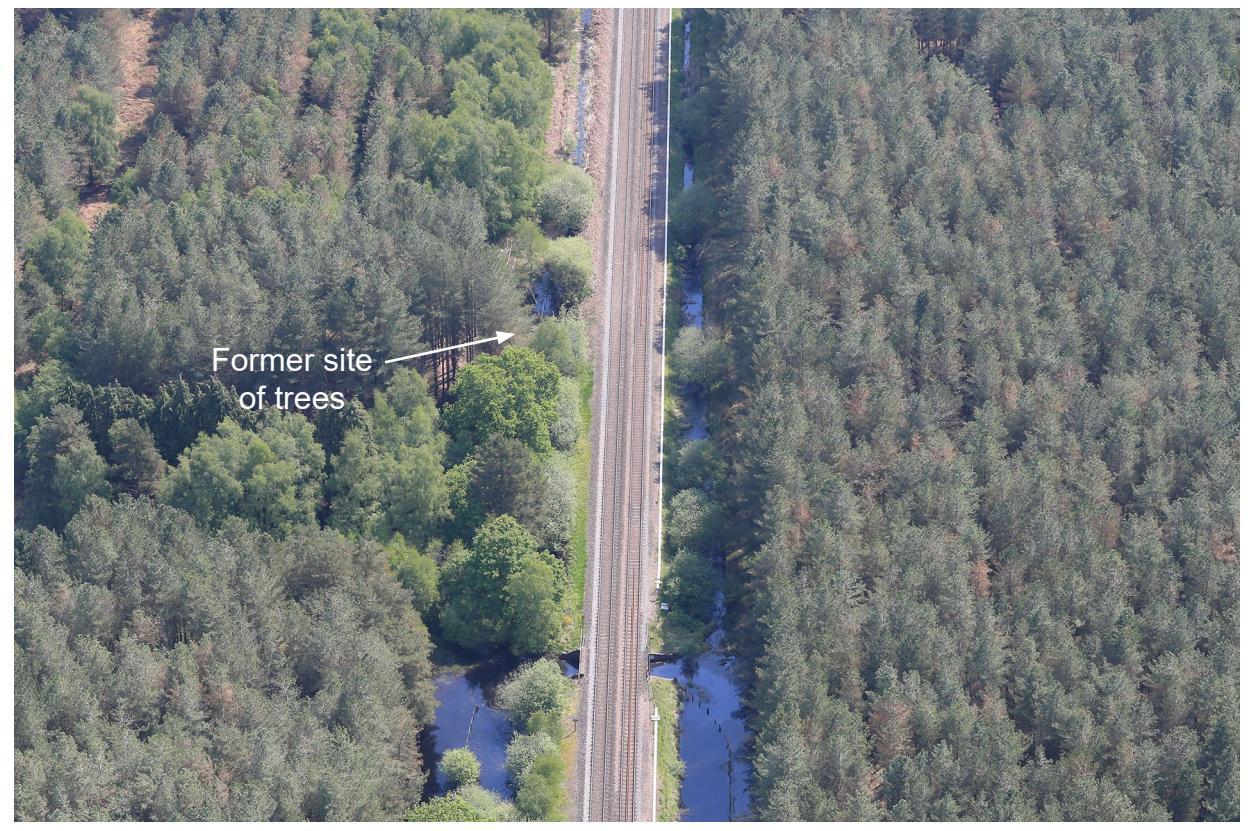
Figure 7: The extent of flooding at the site in May 2024, just over 3 months after the accident. The previous location of the pine and oak trees is indicated (courtesy of Network Rail, with RAIB annotations).

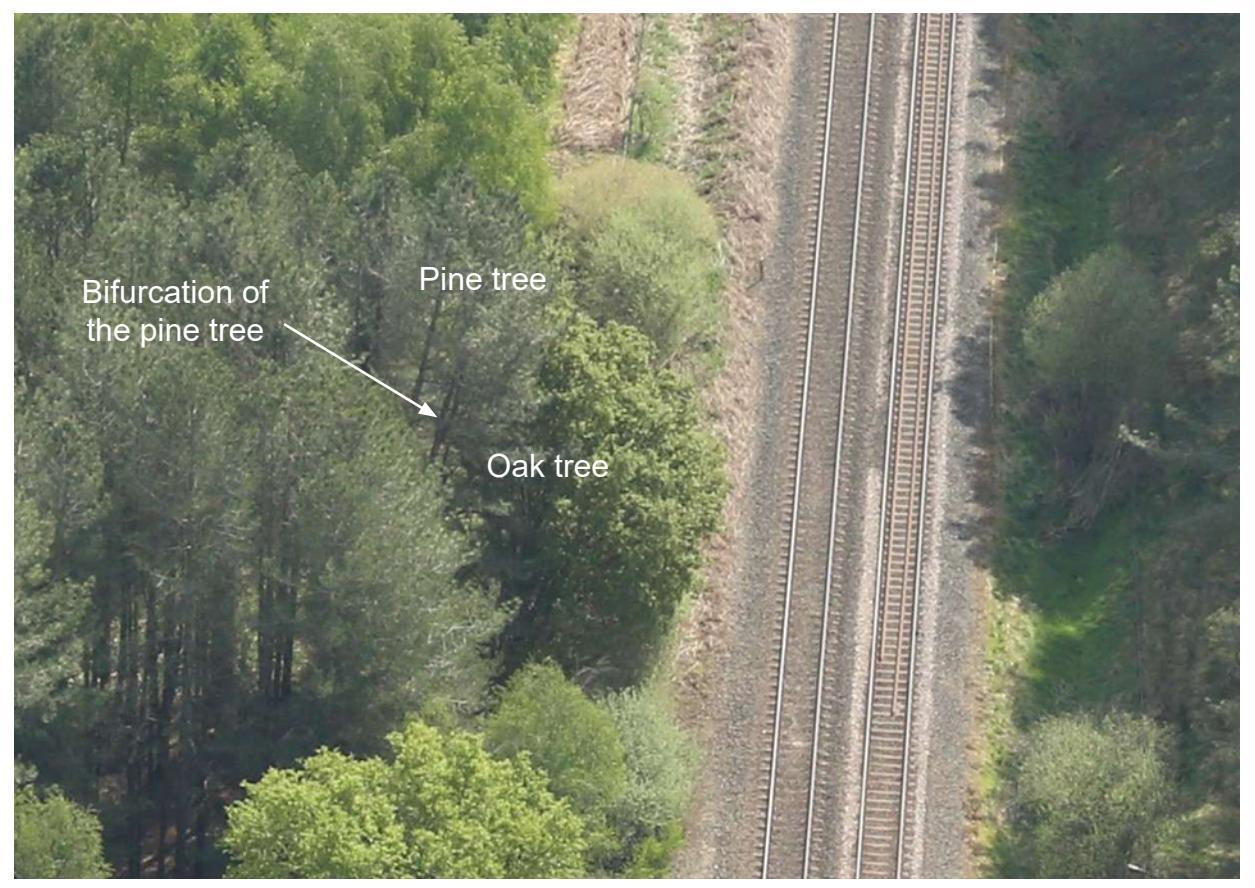
- 57 The pine tree had an offset centre of mass which made it more likely to fall towards the railway.
- 58 An aerial image, taken by Network Rail in May 2022, shows the pine tree with its bifurcated stem growing with a bias towards the railway (figure 8). Based on the post-accident inspection of sections of the pine tree, it is believed that this was a characteristic of its growth, and not rotation of the tree about the MAR. Trees will naturally grow to seek out as much light as possible, and the railway corridor offered a clear space for the pine tree to grow towards, away from the proximity of its immediate neighbours.

Figure 8: Aerial view taken in May 2022 showing the bias in the growth of the pine tree. The bifurcation of the pine tree is highlighted (courtesy of Network Rail, with RAIB annotations).

59 This bias meant that when the tree fell it was more likely to fall towards the railway, regardless of the direction of any wind load which was applied, especially in moderate wind speeds such as those on the day of the accident (paragraph 55).

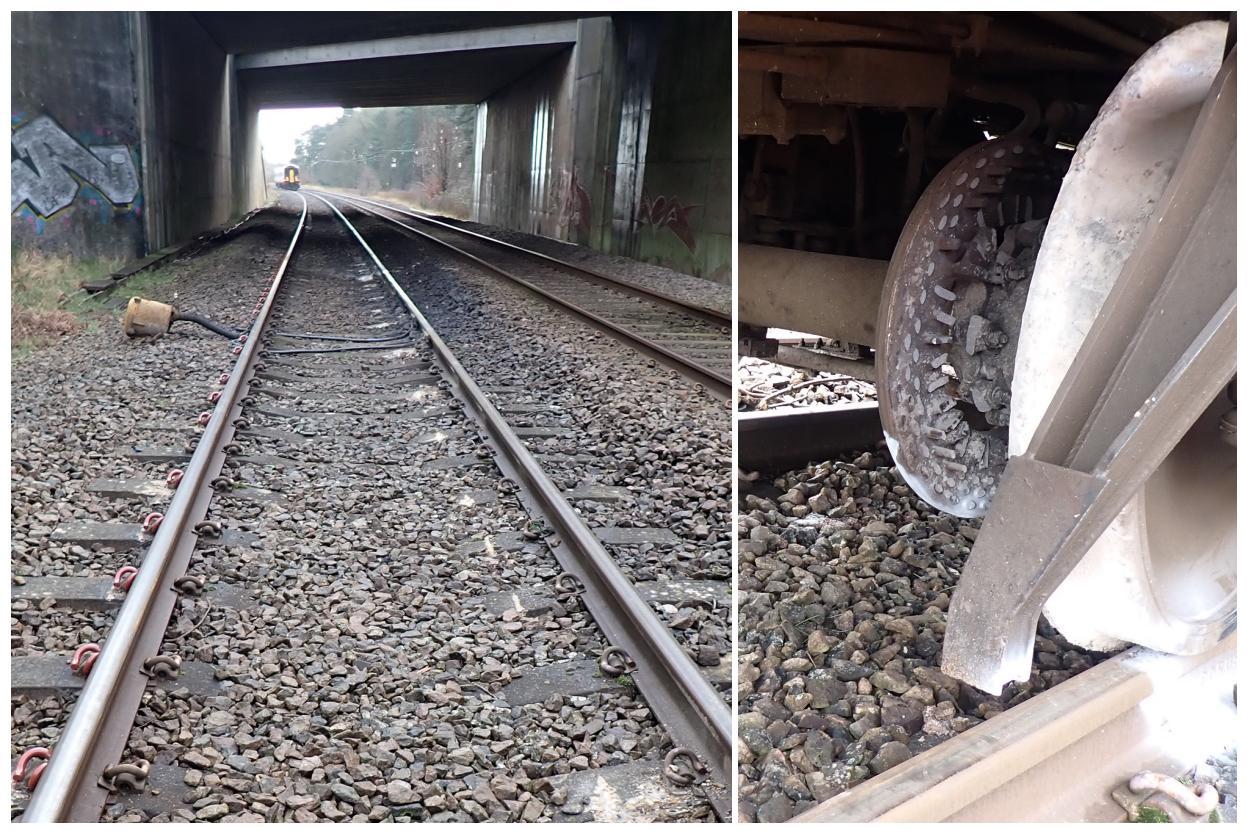
- 32 Around 60 metres from the final position of the train, the brake disc that had been in sustained contact with the left rail fractured and fell onto the track. Without the guidance this disc had been providing, the train began to deviate slightly further to the left, with the left-hand wheel leaving the sleeper ends. However, by this point the train was travelling slowly and it came to rest shortly thereafter.

87 Each wheelset on a class 158 train is fitted with two axle-mounted brake discs (figure 9). Marks on the rail, sleepers and ballast showed the path that the leading wheels of the train took after the derailment, tending to steer to the left as the left wheel engaged with the sleepers and ballast. These marks are consistent with the movement to the left being limited by the engagement of the left-hand brake disc with the left-hand rail (paragraph 30). This prevented any further lateral movement away from the track centreline, which, unrestrained, could have resulted in the train moving further off the tracks or potentially striking the abutment of the A11 dual carriageway overbridge. Around 60 metres before the train came to a stop, the brake disc broke, eliminating the lateral restraint, and the train began to move slightly further from the track centreline (figure 9).

Figure 9: The train's final stopping position beyond the A11 bridge and the sleeper marks made during the derailment (left) and the remains of the axle-mounted brake disc following the train being rerailed (right).
