# Rail Accident Report

## Freight train derailment at London Gateway, Essex 24 December 2021

Report 14/2023  
December 2023

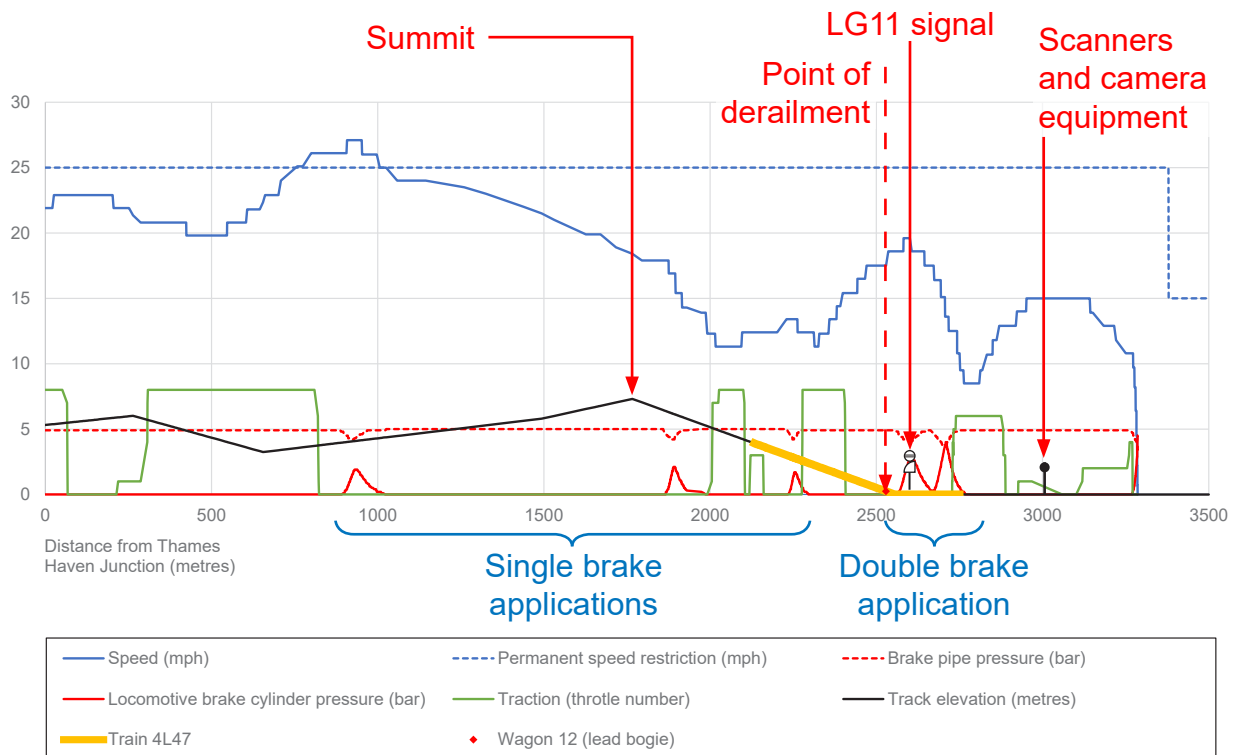
Figure 5: Analysis of the locomotive OTDR for the journey along the Down Thames Haven line.

- 37 Train 4L47 passed over Thames Haven Junction at around 22 mph (36 km/h). The locomotive OTDR recorded a mixture of traction effort demands and single brake applications as it continued to the summit and then descended the 1 in 108 gradient to LG11 signal. The driver recalled the signal clearing as the train approached. The OTDR recorded two consecutive brake applications (a 'double brake application') shortly after the front of the train passed the signal. At this time, wagon 12 was approaching the point of derailment. Together with the derailment marks and other evidence (see paragraphs 42-44), the OTDR analysis shows that the leading bogie on wagon 12 derailed as the brakes were releasing after the second of the two brake applications.

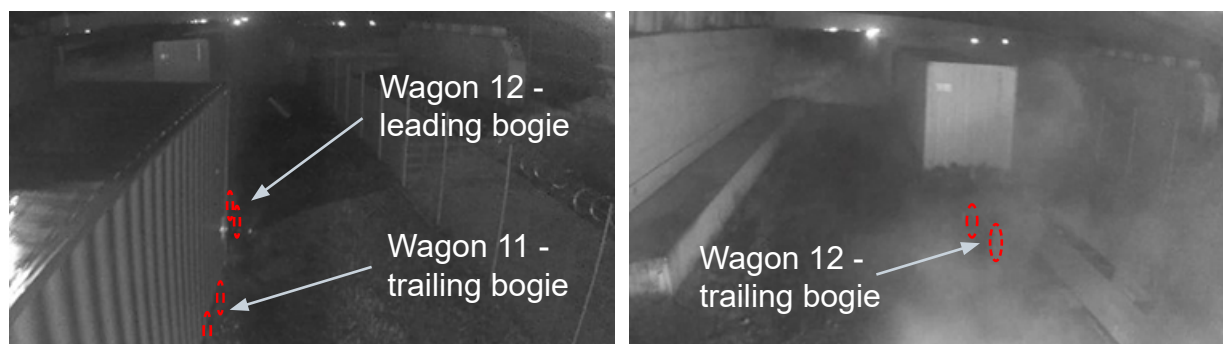
45 Closed-circuit television (CCTV) images from the lineside cameras (paragraph 30) showed that three bogies in total had derailed by the time wagon 12 was running on the Thames Haven Single line (figure 8). These were the trailing bogie on wagon 11 and both bogies on wagon 12. All three of these bogies were shown running derailed to the left. RAIB concluded that the trailing bogie on wagon 12 and the trailing bogie on wagon 11 had been drawn into derailment due to the path that the already derailed leading bogie of wagon 12 was forced to take as it ran through LG1 points, where the Up Thames Haven and Down Thames Haven lines join to form the single line (paragraph 13). Marks and damage on the track at LG1 points support this.

Figure 8: CCTV images of train 4L47 passing the London Gateway port cameras and OCR scanners (images courtesy of DP World).

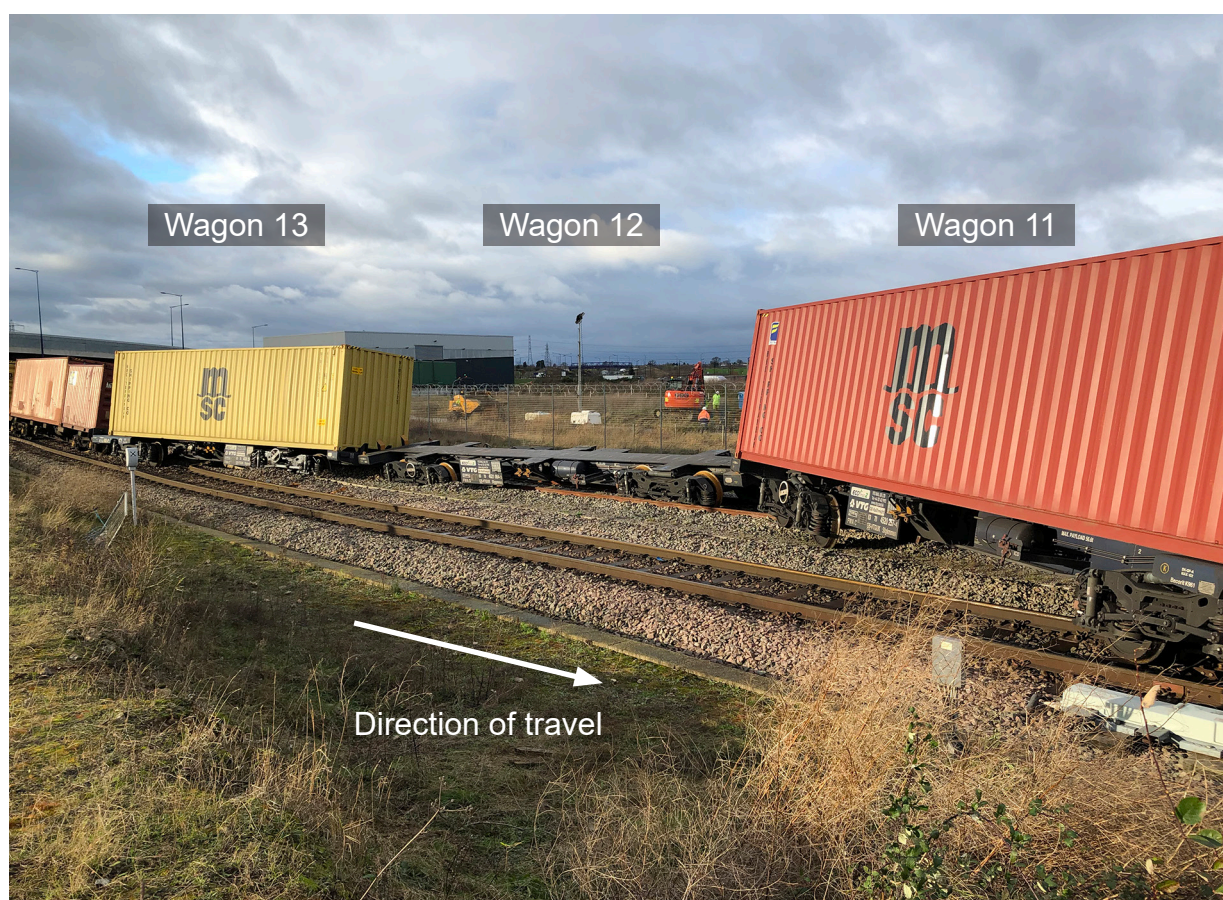
- 46 When the derailed train reached LG2 points, the leading bogie on wagon 11 and both bogies of wagon 13 also derailed (figure 9).

Figure 9: Final position of Wagons 11, 12 and 13 (photograph courtesy of VTG Rail).

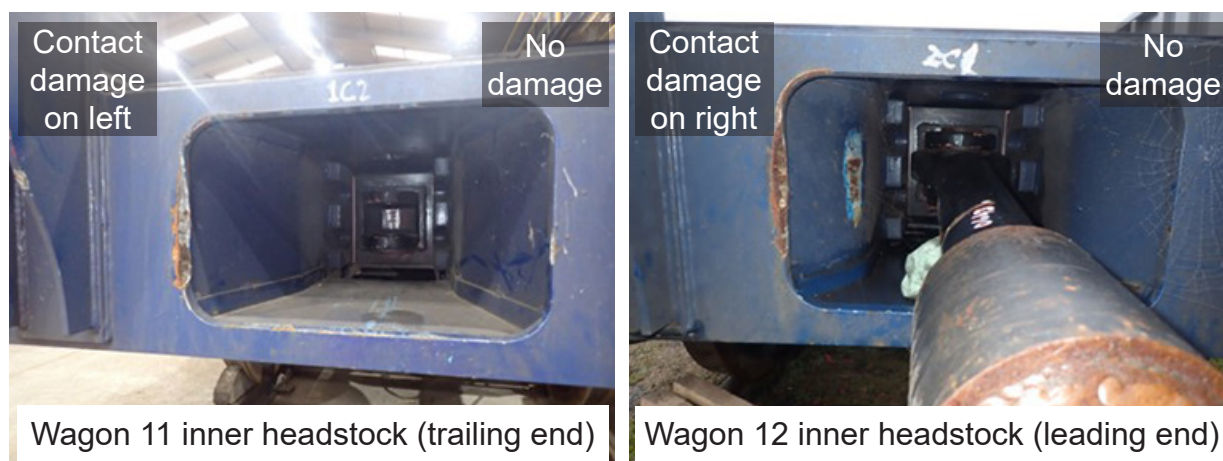
- 66 RAIB identified witness marks on the headstock pockets where wagon 11 and wagon 12 were coupled together (figure 14). The marks were consistent with the leading end of wagon 12 running derailed to the left and the rigid drawbar coming in to contact with the headstock pockets as a result. The marks were only found on one side of the headstock pockets. From this, and the available CCTV evidence (paragraph 45), RAIB has concluded that the leading bogie of wagon 12 was the first to derail.

Figure 14: Witness marks on the headstock pockets on wagon 11 and wagon 12 after recovery (rigid drawbar is shown disconnected from wagon 11, and after a weld repair had been done).

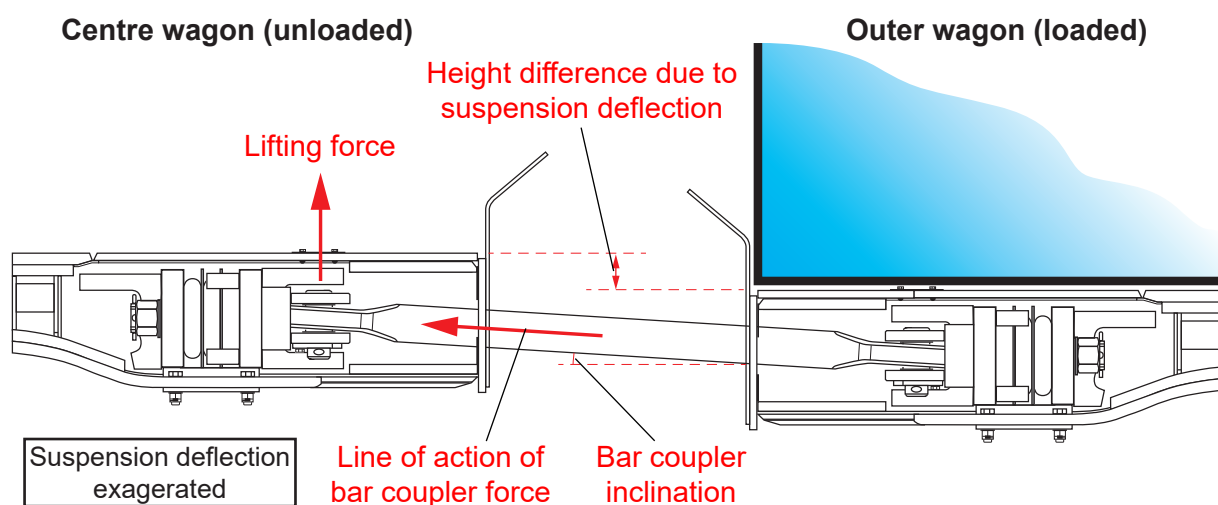
- The lack of payload caused the bar couplers to become inclined, because the outer wagons (wagons 11 and 13) were loaded and therefore lower on their suspension. This provided a line of action resulting in forces that tended to lift the centre wagon (figure 20).
- The lack of payload reduced the wheel load that the lifting forces needed to overcome.

Figure 20: Bar coupler inclination and resulting centre wagon lifting force.

123 The modification to lengthen the bar coupler on the Ecofret 1 triple-wagon (paragraph 76) had helped to address the first vulnerability because it reduced the angle of inclination and hence the tendency for the centre wagon to lift when longitudinal compressive forces were applied. A loading restriction had been introduced to manage this vulnerability following the derailments at Felixstowe and Peterborough. The bar coupler modification had allowed this restriction to be removed (paragraph 77). A loading restriction of this nature was never applied to Ecofret 2 wagons, and RAIB found no evidence of any other instruction that meant wagons 11, 12 and 13 had been loaded contrary to the rules and guidance in force at the time of the accident.

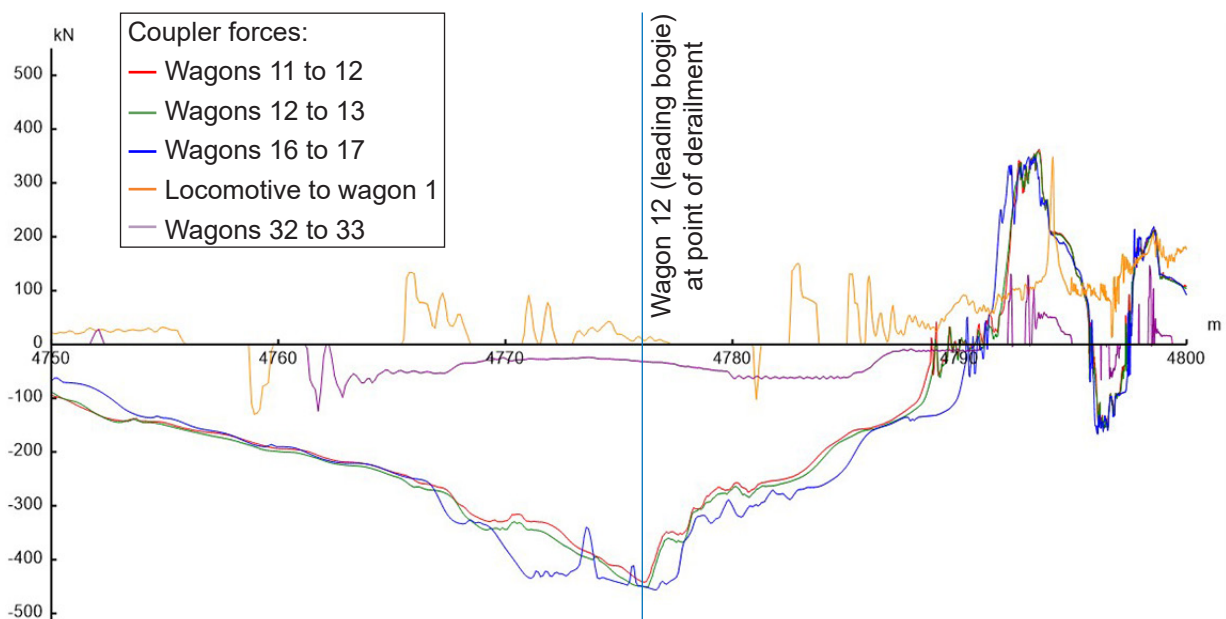
131 Wagon 12 was in the middle part of the train. The longitudinal train dynamics simulation model predicted that, around the time of the derailment, the longitudinal compressive forces were highest in the coupler connecting wagons 16 and 17, which was the coupler at the centre of train 4L47. The longitudinal compressive forces acting in the couplers either side of wagon 12 were predicted to be only slightly less (figure 21).

Figure 21: Predicted variation of the force in the couplers at different positions along train 4L47 around the time of the derailment – sensitivity study C4. Plot shows the forces predicted in the couplers: either side of wagon 12; between wagons 16 and 17; between the locomotive and wagon 1; and between wagons 32 and 33.

132 While wagon 17 was the centre wagon of an Ecofret 2 triple-wagon, it was carrying a relatively heavy container (table 1). RAIB concluded that the high longitudinal compressive force generated in this part of the train, in combination with the lack of container payload (paragraph 121), made wagon 12 particularly vulnerable to the effects of longitudinal compressive force. The compressive forces in the couplers at the outer ends of the train (between the locomotive and wagon 1, and between wagons 32 and 33) were predicted to be negligible by comparison.

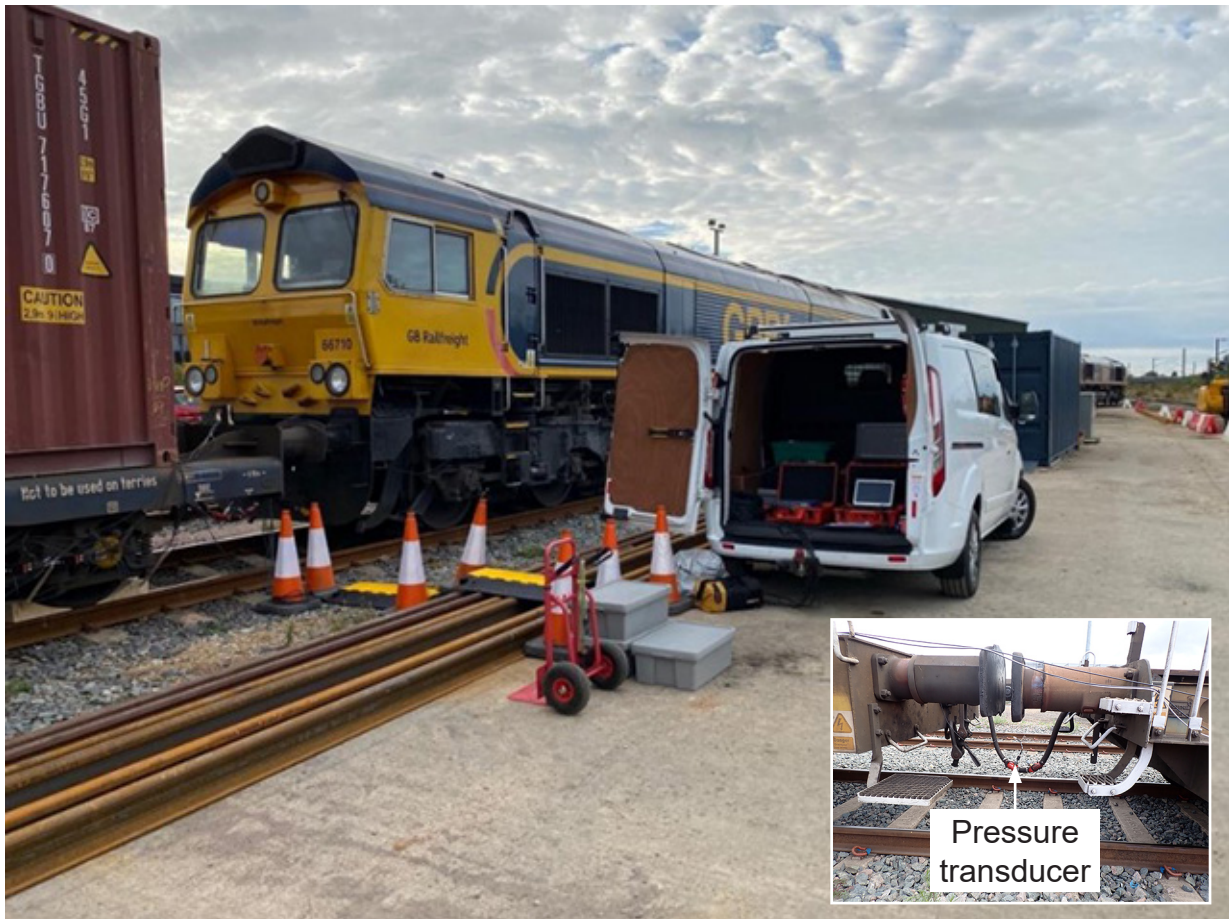
- B2 Two intermodal trains were made available on separate dates for brake testing. Each was formed of a class 66 locomotive and a similar number of wagons. Ecofret 2, FEA-A, FEA-B and FEA-C type wagons were included on both trains. Pressure transducers were added to various brake pipe and brake cylinder test points. The driver’s brake valve was operated with the train stationary and the resulting pressure measurements were recorded using a data acquisition unit (figure B1).

Figure B1: Brake testing arrangements. Inset shows pressure transducer fitted to a test point in the train brake pipe. (Main photograph courtesy Railway Braking Associates Limited).
