Rail Accident Report

Collision between road-rail vehicles near Ramsden Bellhouse, Essex 2 May 2021

Report 09/2022
September 2022

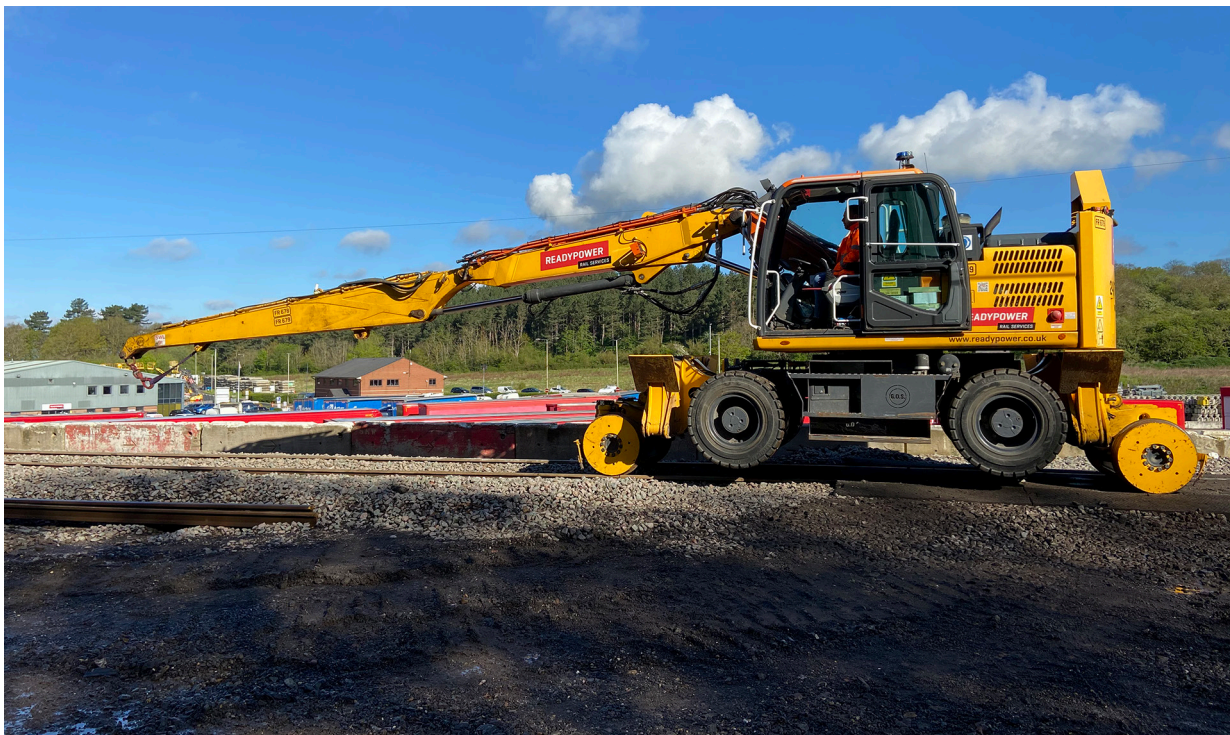
14 The crane involved was a Doosan Ultimate 270 road-rail machine equipped with a 5.5 metre 'long reach dipper' arm, rigged for lifting operations (figure 5).

Figure 5: The crane involved in the collision during brake testing
