Rail Accident Investigation Branch

Rail Accident Report

Freight train derailment at Petteril Bridge Junction, Carlisle 19 October 2022

Report 10/2023
October 2023

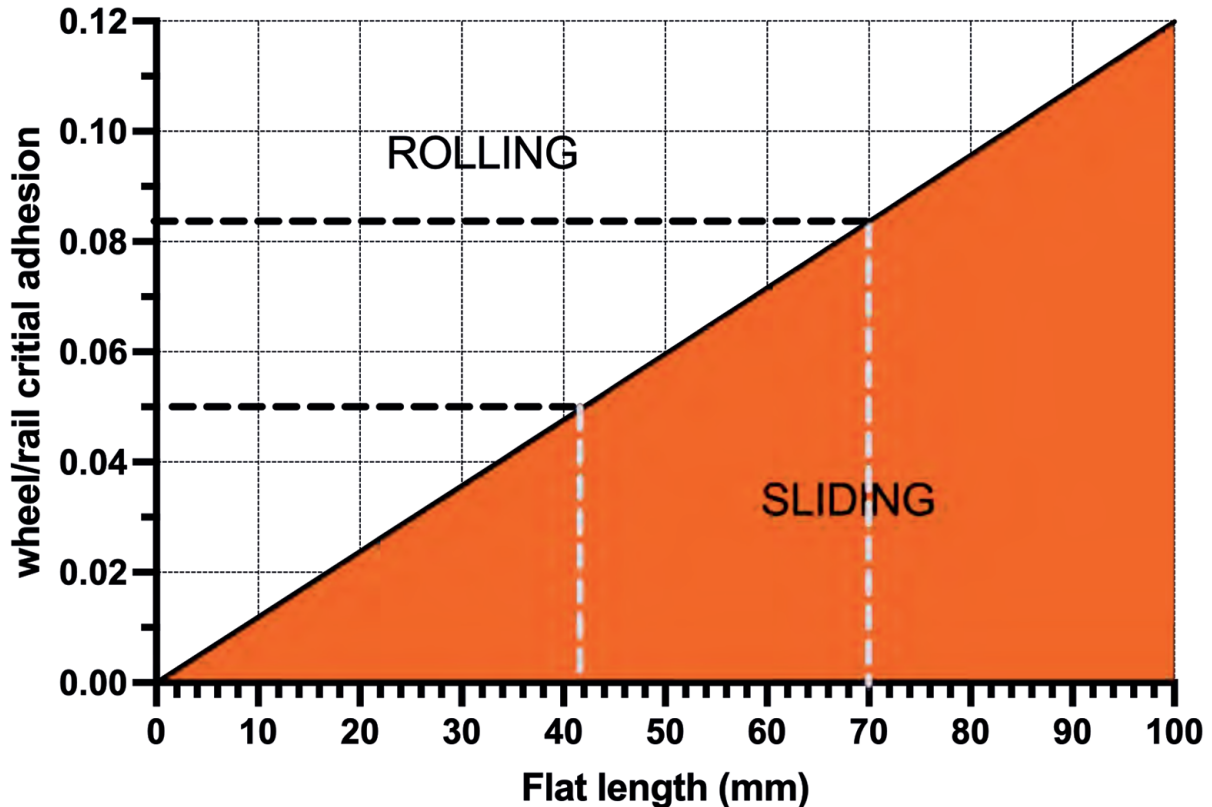
Figure 36: Plot showing the relation between wheel/rail critical adhesion and the flat length.

- 115 As the slide is maintained, the wheel flat will get larger, and the friction required for the wheel to be able to start rotating again also becomes larger. By the time the flat gets to 100 mm, the adhesion level then required needs to exceed 0.12, which is higher than the average seen (even with sand present) on the climb from Settle to Ribbleshead.
