# Rail Accident Report

## Passenger train collision with a road vehicle at Redcar level crossing, Redcar and Cleveland 1 May 2024

Report 05/2025  
April 2025

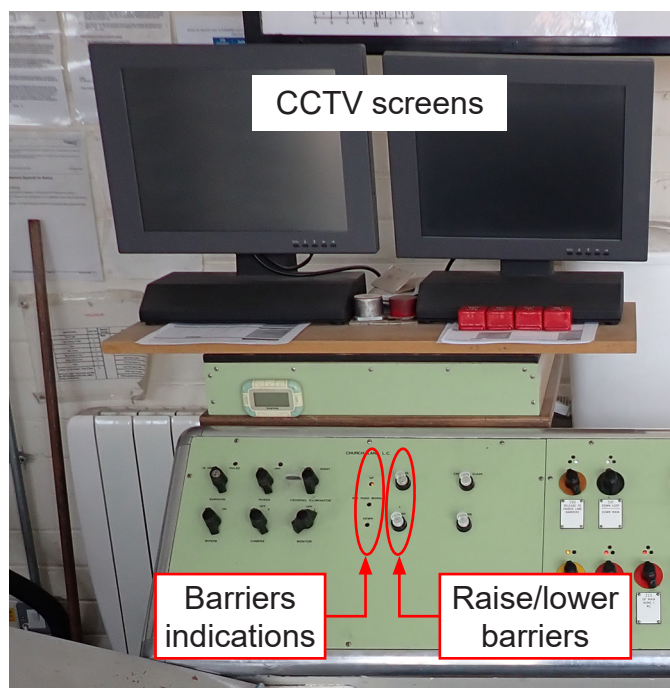
Figure 5: Church Lane level crossing controls and CCTV.

- 121 The controls for Church Lane level crossing, including the CCTV display, are located at the signalling panel (figure 5 and paragraph 38). The controls for Redcar level crossing are located away from the signalling panel at the end of the signal box, meaning that the signaller has to walk across the box floor to reach them every time they are operated, or the crossing status needs to be checked (figure 14 and paragraph 39). This allows a signaller to have a clear view of the road and pavement while operating the Redcar level crossing controls.

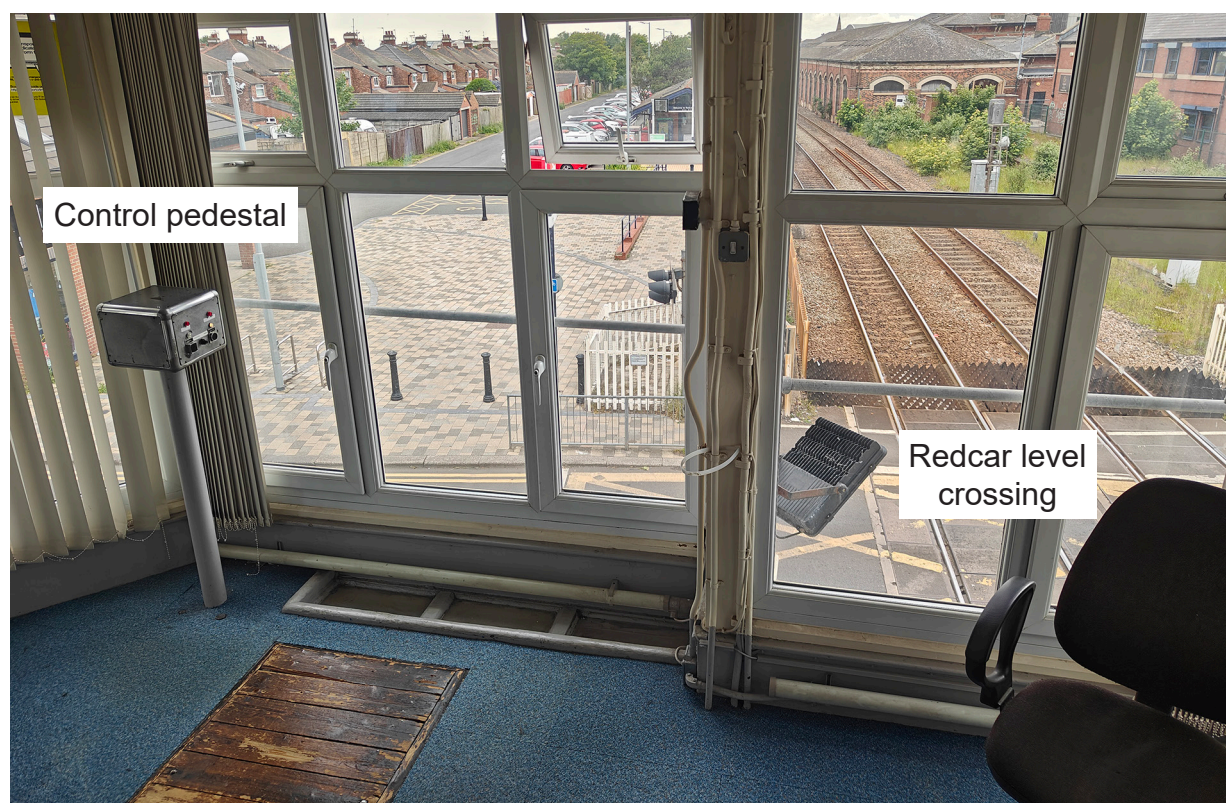
- 39 The second crossing which westbound trains will encounter is Redcar level crossing. This is adjacent to the signal box and is fitted with horizontally sliding gates (see paragraph 94). It is controlled by the signaller from a pedestal located by the window in the signal box, overlooking the crossing (figure 6, see paragraph 121). This crossing is not visible from the signaller's seat at the signalling panel and can only be seen by the signaller if they walk over to the end window.

Figure 6: Redcar level crossing and control pedestal.

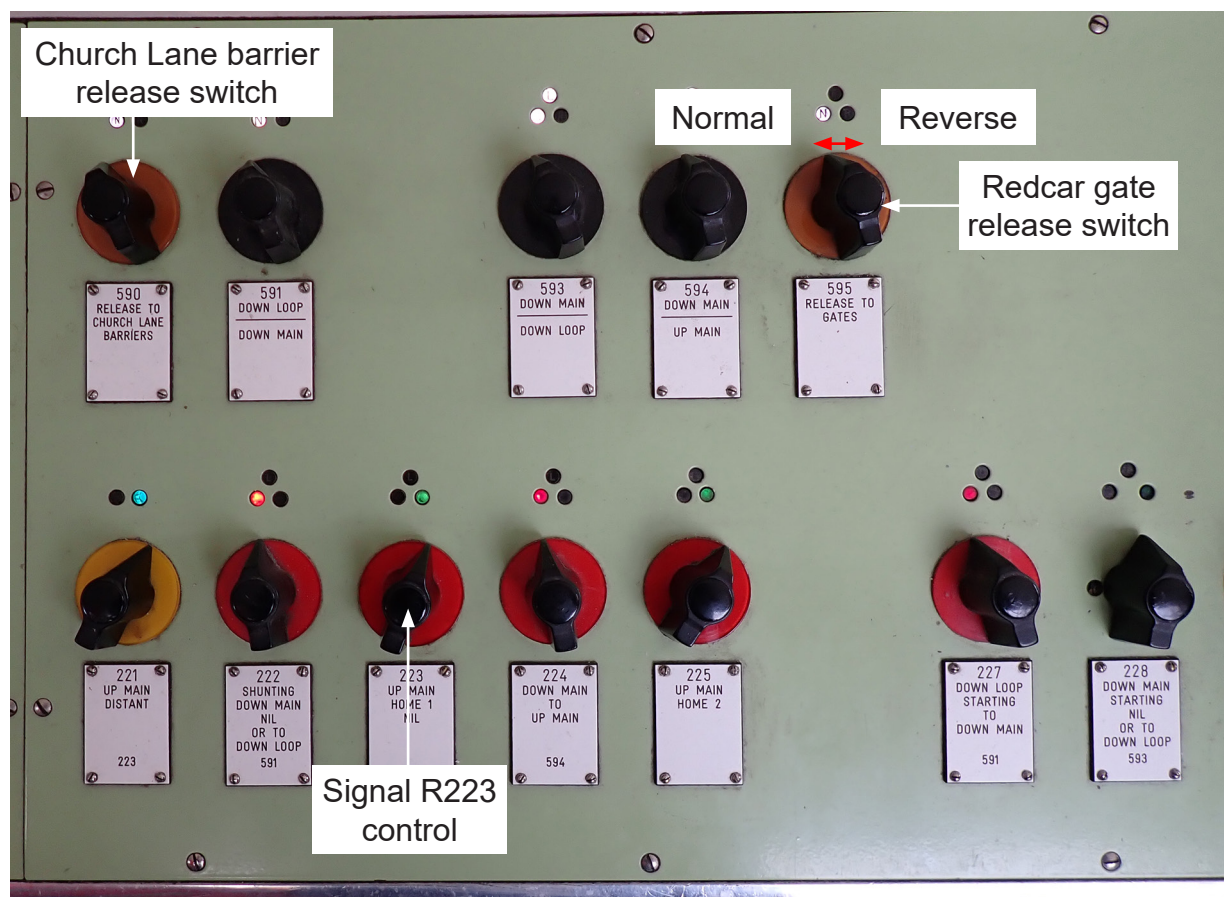
- The first step is to set the crossing release switch on the signalling panel for Redcar to the reverse position (figure 8). This enables the operator controls at the pedestal by the window overlooking the crossing.

Figure 8: Signalling controls, showing crossing releases and signal R223.
